**Arulmighu Shree Pundarikatcha Perumal Thirukoil
RajaGopura Thiruppani**

15 December 2016

REPORT - 1

**ARULMIGHU THIRU PUNDARIKATCHA PERUMAL THIRUKOIL
RAJAGOPURA THIRUPPANI - FINAL REPORT**

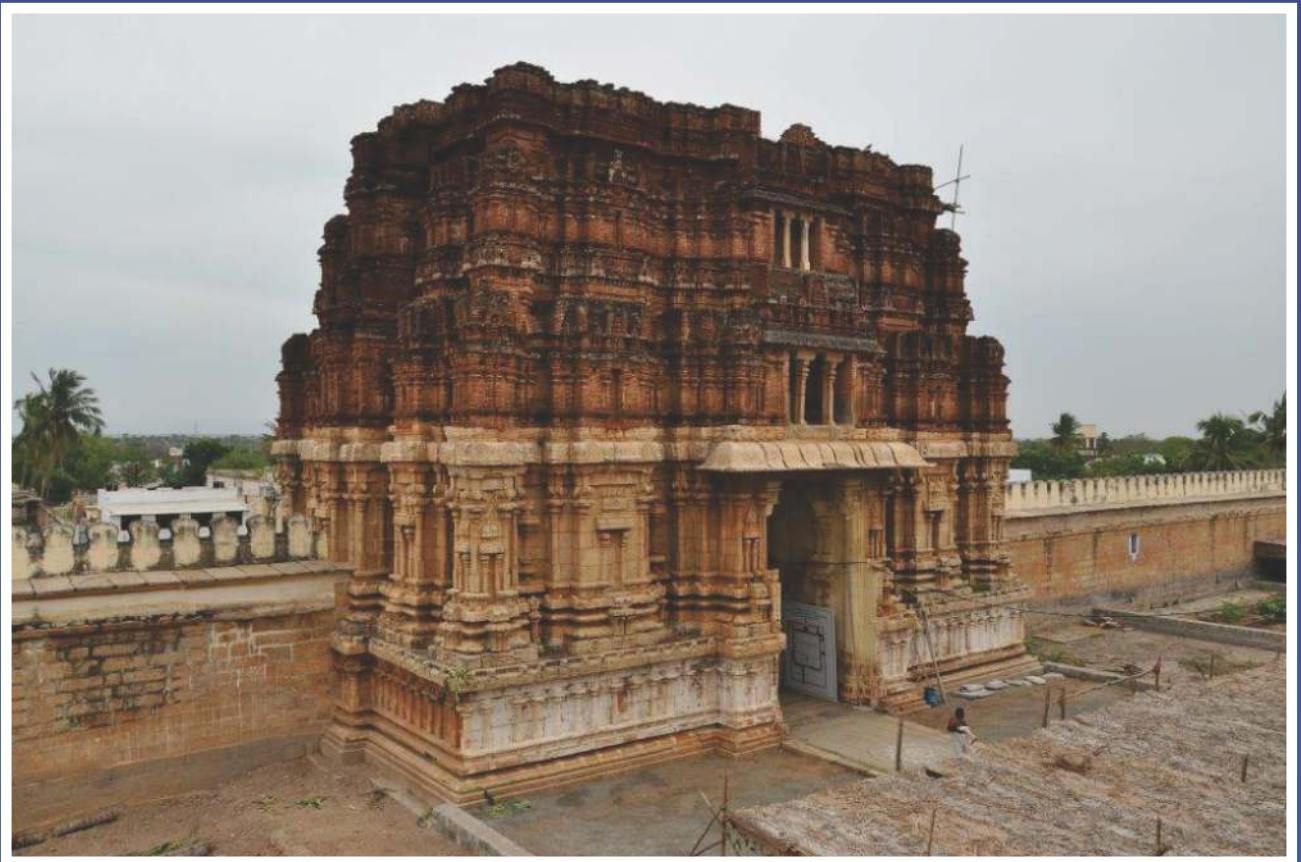
The base of the existing Rajagopuram in Thiruvellarai is a one storeyed stone structure. Above this stands two storeyed brick super structure. When completed this Rajagopuram will have seven storeys and will be nearly 110 feet in height.

Existing Gopuram in the Northern Entrance

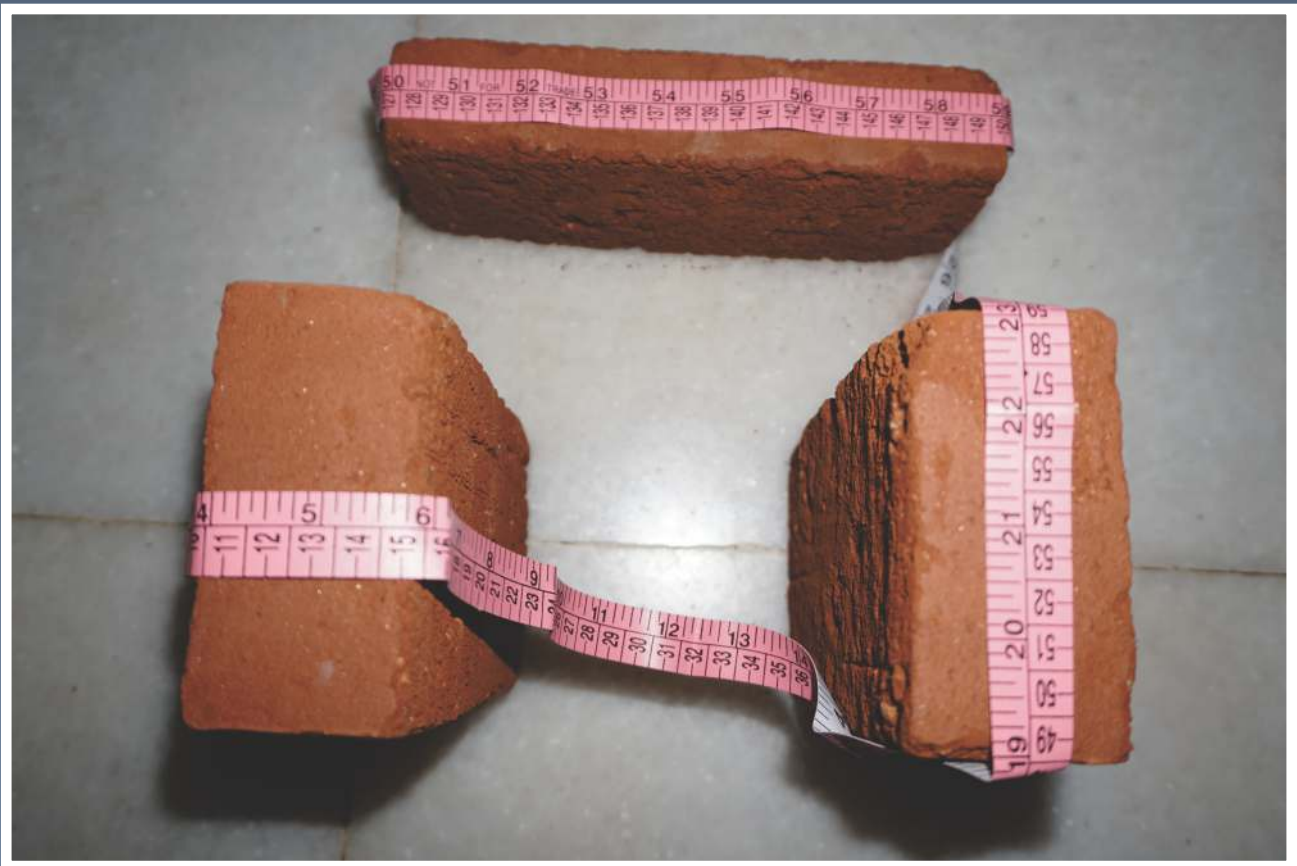
Picture of the bricks with measurements

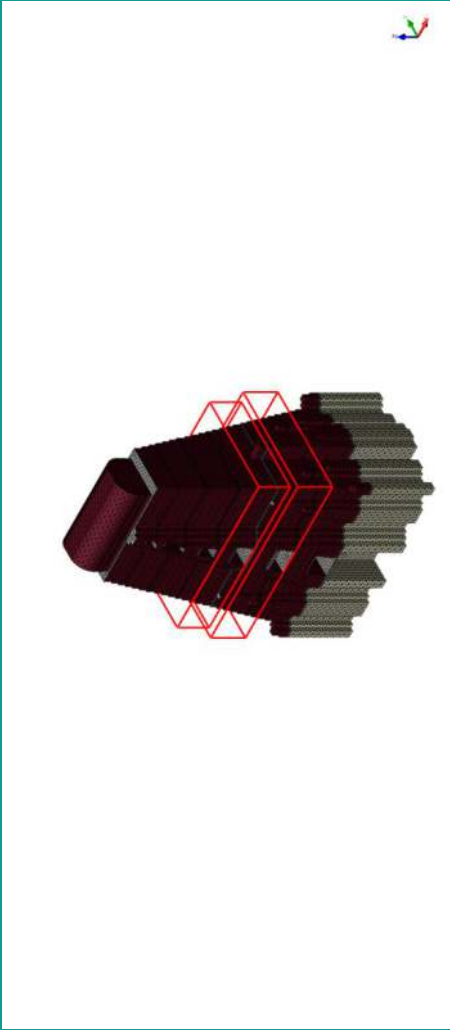
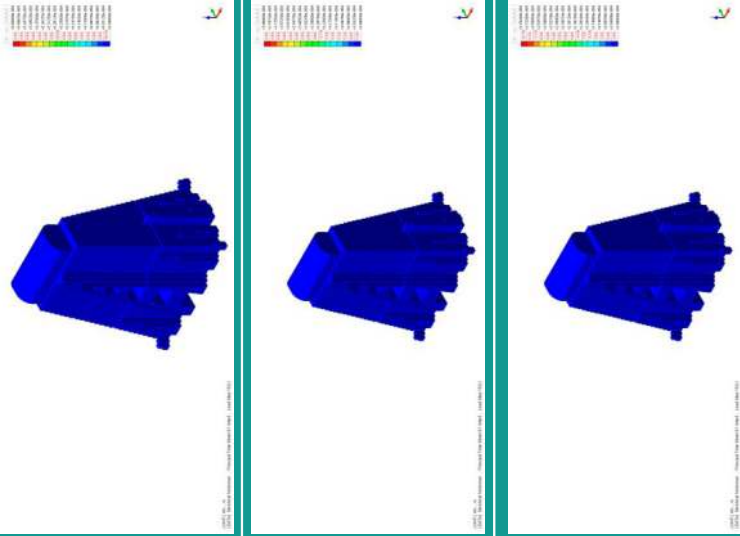
<p style="text-align: right;"><u>LEVEL 3&4</u></p>

LOCATION
1	LE NL INTERACTION FAILURE ?
2	BRICK INFILL COMPRESSIVE FAILURE
3	TENSILE AND LE NL INTERACTION FAILURE
4	BRICK INFILL COMPRESSIVE FAILURE
5	LE NL INTERACTION FAILURE ?
6	TENSILE AND LE NL INTERACTION FAILURE
7	LE NL INTERACTION FAILURE?
8	TENSILE AND LE NL INTERACTION FAILURE

1,5 &7	LE NL INTERACTION FAILURE ?	BRICK 1.2,8,2.19,3.46 C1 PROPOSED STATES
LOCATION		PRINCIPAL STRAINS S1

- C1 shows no significant damage at all.
- Damages 3,6 & 8 are of primary interest and they occur only in C2. Additionally they decrease with increasing brick strength: almost negligible when the strength of brick masonry is assumed to be 3.46.
- A part of the damage is due to interaction of L and NL elements. Could this damage be aggravated by the concentration of stresses being caused by that ?
- How important is 2 &4 ??
- To see how much these results are influenced by the properties of the infill, the properties of the infill are varied and studied now.

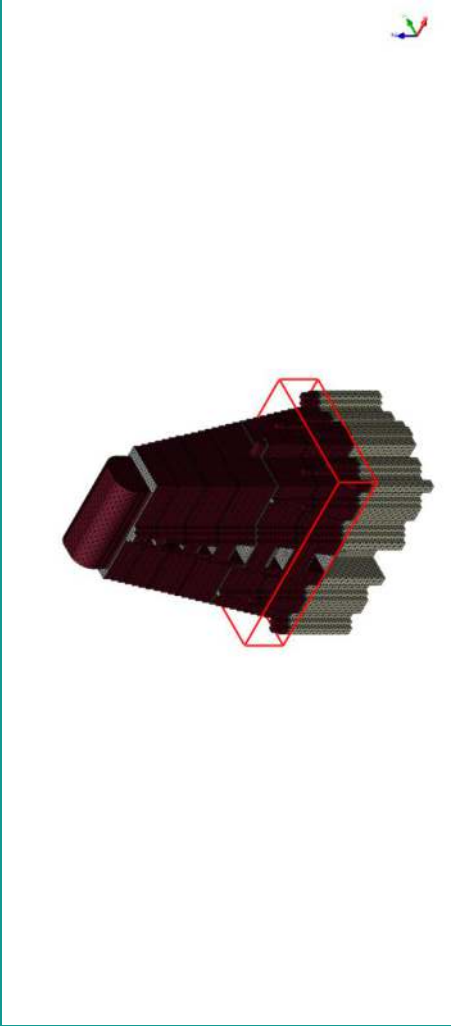
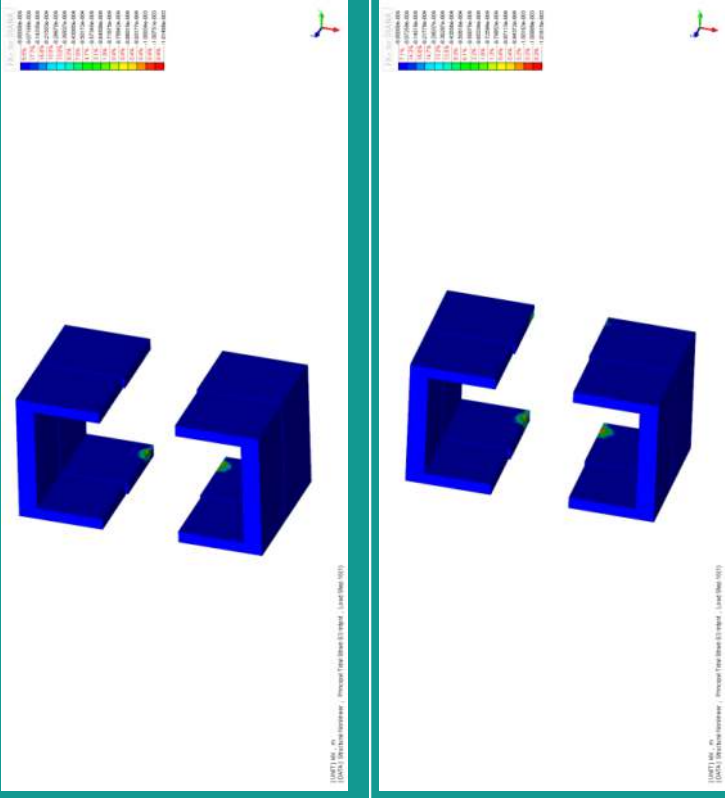
<p style="text-align: right;">LEVEL 2</p>

2 &4	BRICK INFILL COMPRESSIVE FAILURE LOCATION	BRICK 1,2,8 C1 & C2 PROPOSED STATES PRINCIPAL STRAINS S3

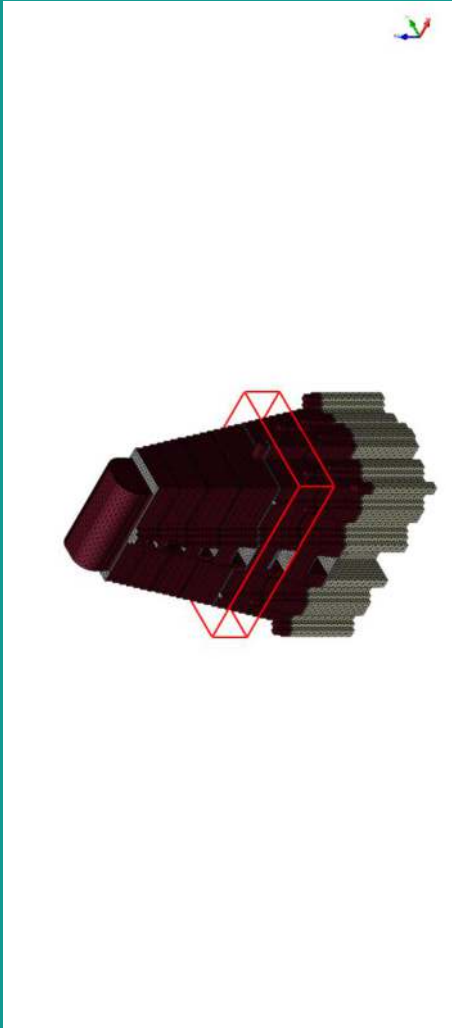
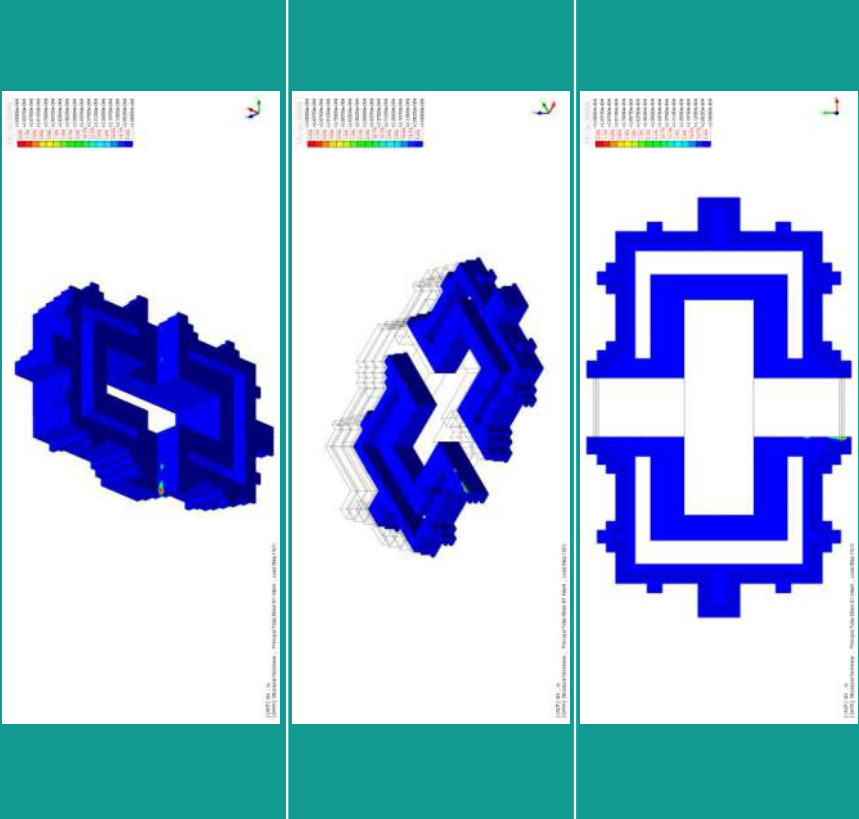
<p style="text-align: right;">LEVEL3</p>
BRICK 3.46C2 PROPOSED STATES	<p style="text-align: center;">PRINCIPAL STRAINS S1</p>

8	TENSILE AND LE NL INTERACTION FAILURE
