**Arulmighu Shree Pundarikatcha Perumal Thirukoil
Rajagopura Thiruppani**

REPORT - 5 (Jan 2018 - 15 Mar 2019)

**REPORT - 5
January 2018 - 15 March 2019**

**Status report
Since our earlier Report-4 January 2018**

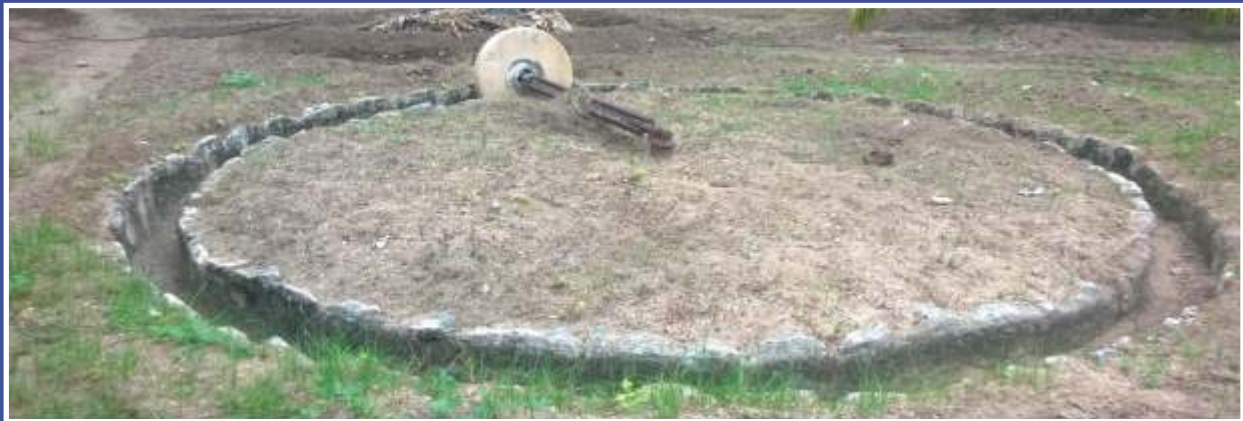
Traditional method

In the traditional process the granite roller what is seen in the picture is driven by two bullocks traveling in a circular path, enabling the grinding of the lime and sand mixture with the addition of water.

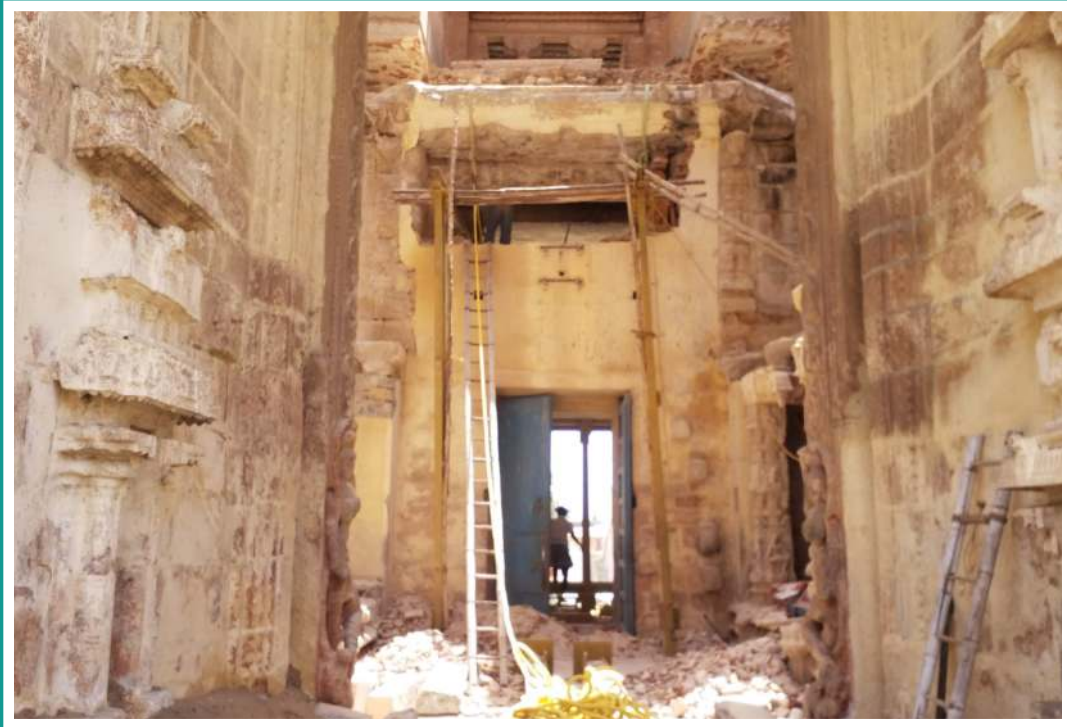
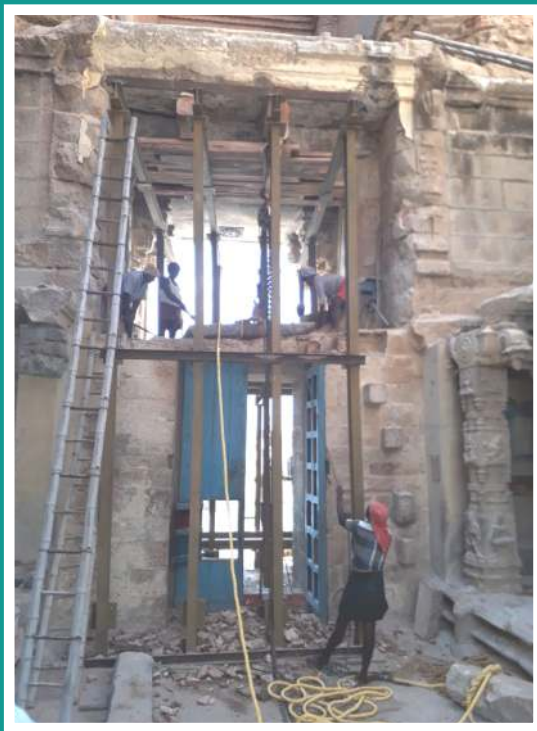
We understand around 1960s some renovation work was going on to refurbish the ceiling, the beams & pillars.

During the process of removal of the ceiling because of the problems faced, they constructed a RCC concrete ceiling and the front entrance was reduced from 20' height to 10' height, erected a 6' width wall on east and west & extended it to the ceiling and installed a temporary door 6' width and 10' height.

View of the damaged door frame

After dismantling being completed, we started working on the front door removal and replacement

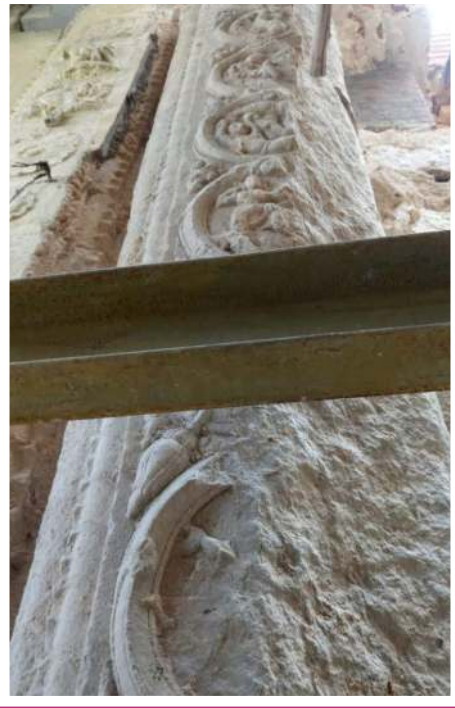
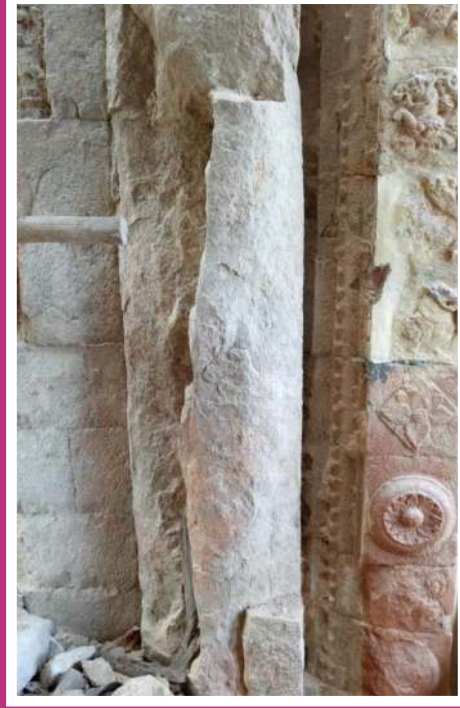
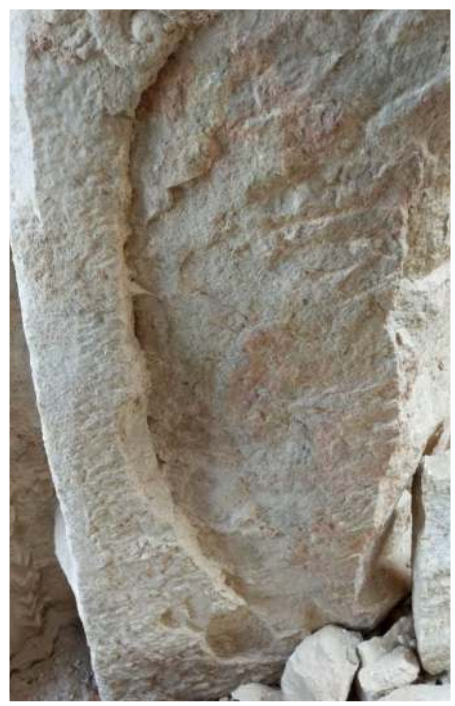
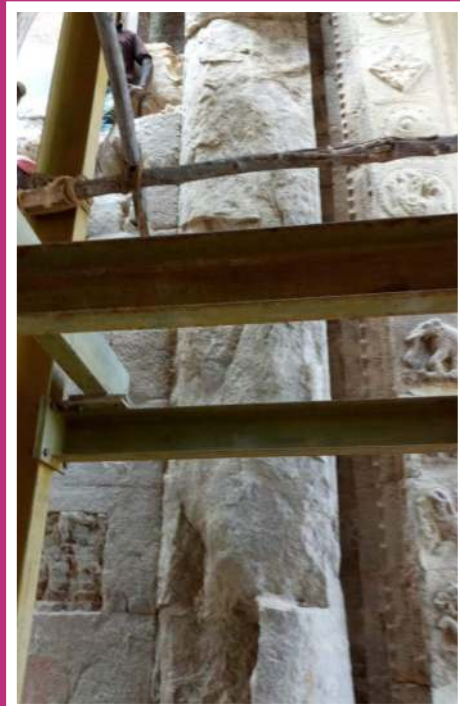
Damaged door frames - Eastern & western side

These door frames in the East & Western sides were heavily damaged. Hence a temporary wall was built and the main door installed with width 6' & height 10'.

On the auspicious day 23 January 2019 Wednesday, the door frames one each on the east and west (with highly complicated carvings) each weighing 17,500 kg was lifted to its final position, in the midst of the **Brahma sthuthi parayanam**, chanted by about 30 people arrived from Coimbatore.

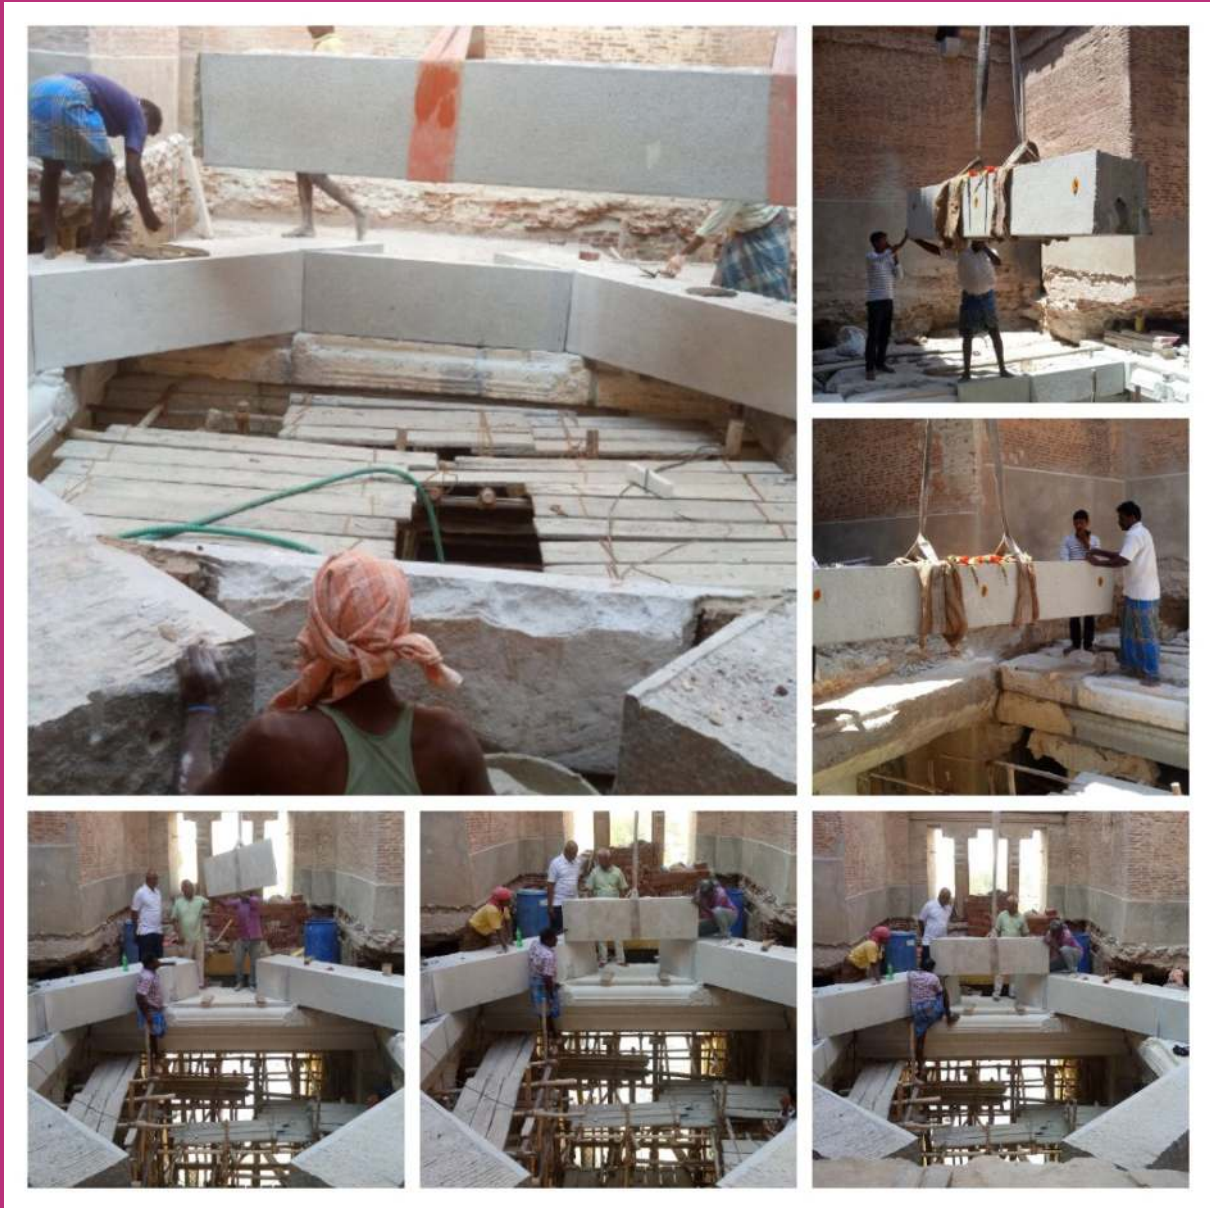
15.1 Konakkal - Octagon shape

The opening in the ceiling - between the kathavadis (North-south) - is about 15' x 15' square. This is to be reduced to 11' x 11' square to enable easy assembling and to reduce the dead weight on the ceiling as much as possible. Therefore, we have to introduce an Octagonal shape on top of the kadhavadis. This picture explains the assembly of the octagonal shape. The drawings also explain the same concept.

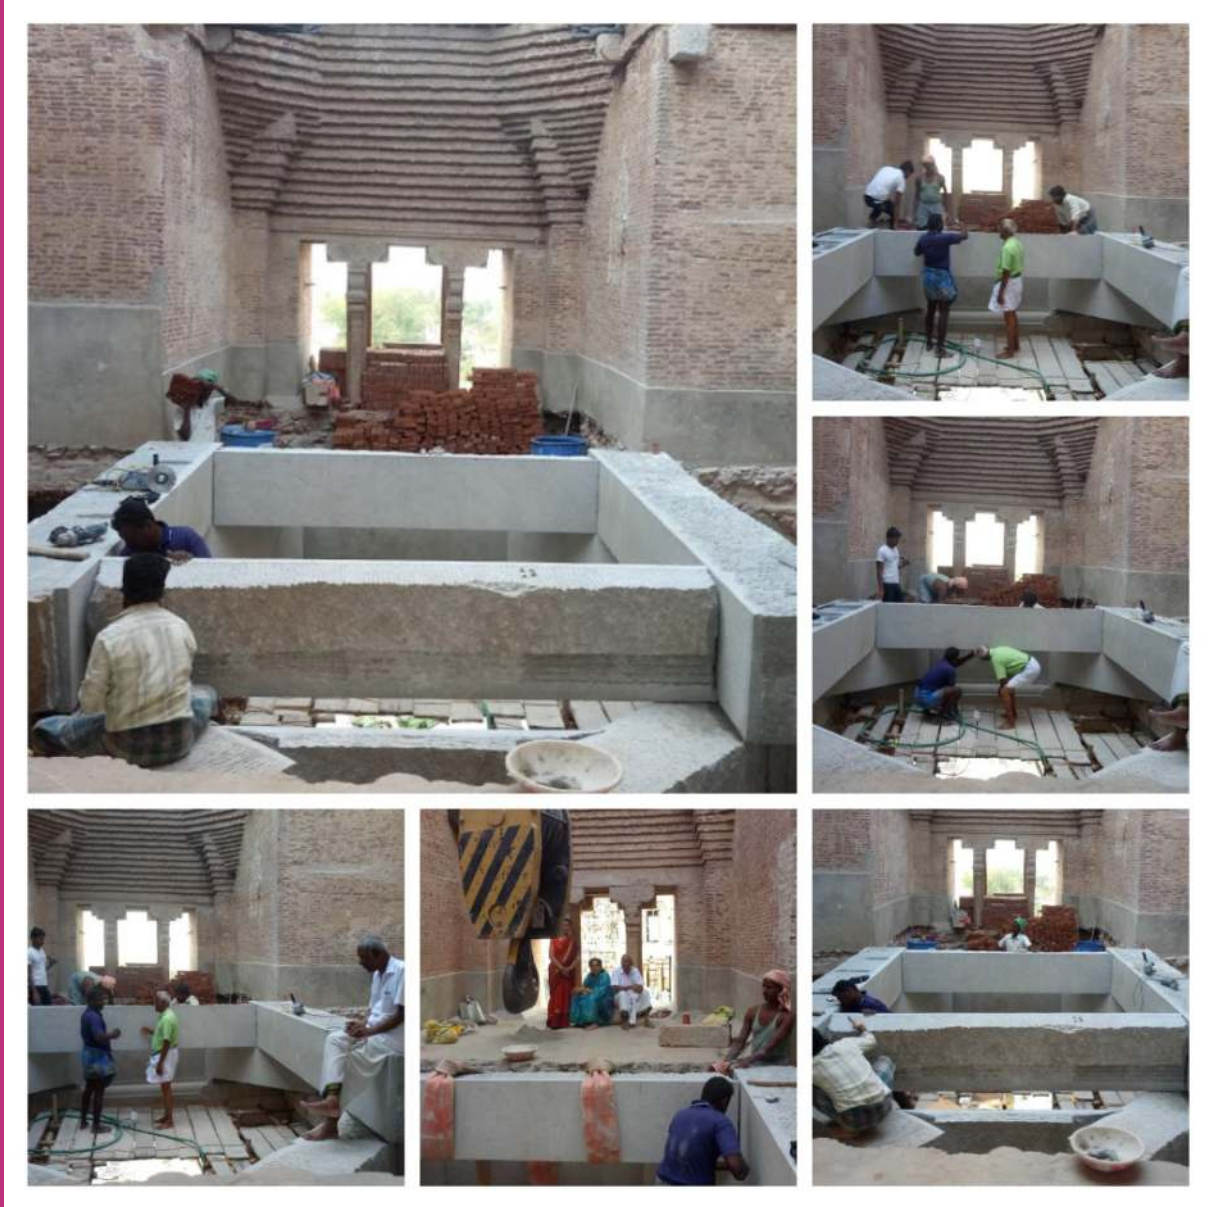
15.2 Square shape

Over and above this square shape pavakkal - granite slabs with the carvings will be placed.
Thus completing the assembly of the ceiling.

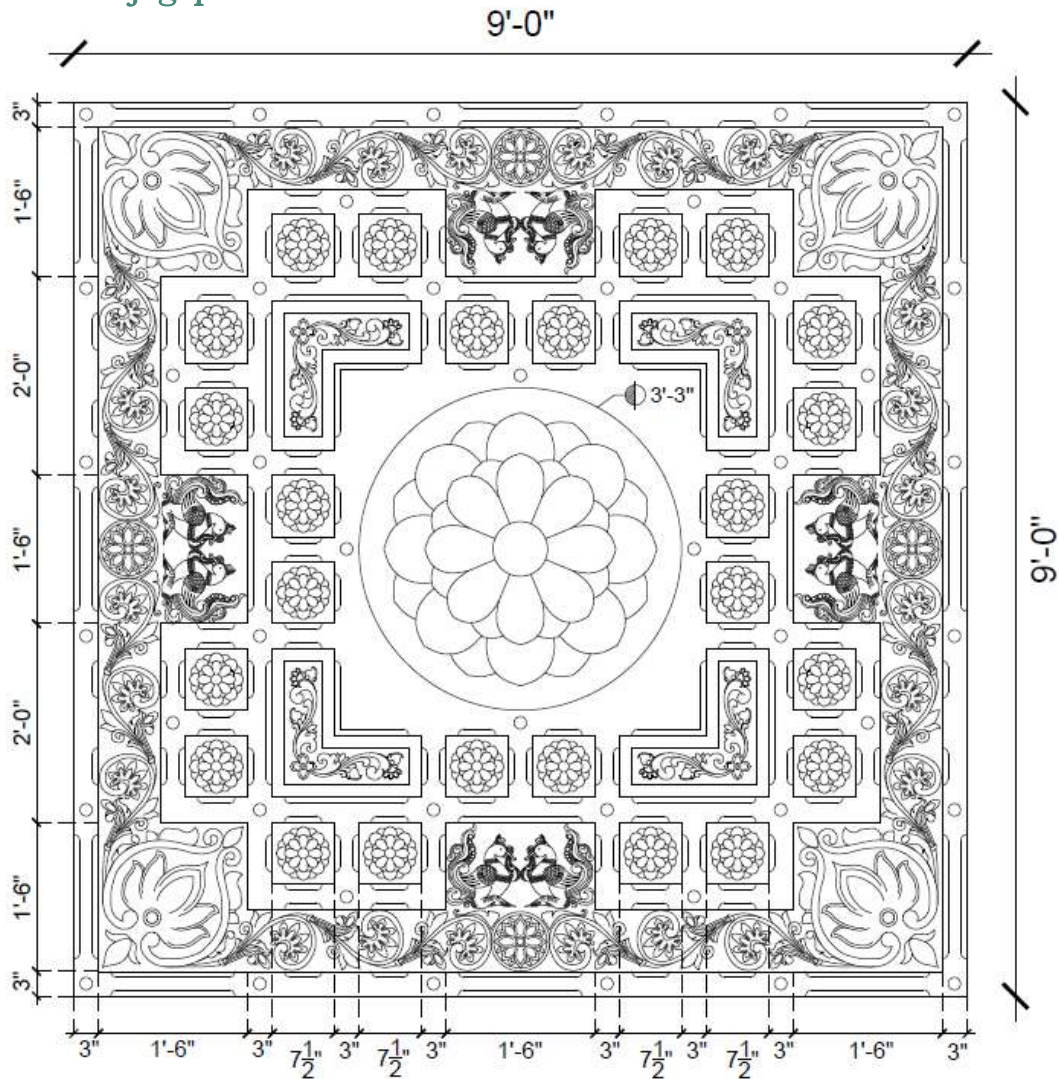
Revised Detailed Design

In accordance with the Hoysala Architecture, we have designed the suitable carvings for the ceiling inside the Rajagopuram.

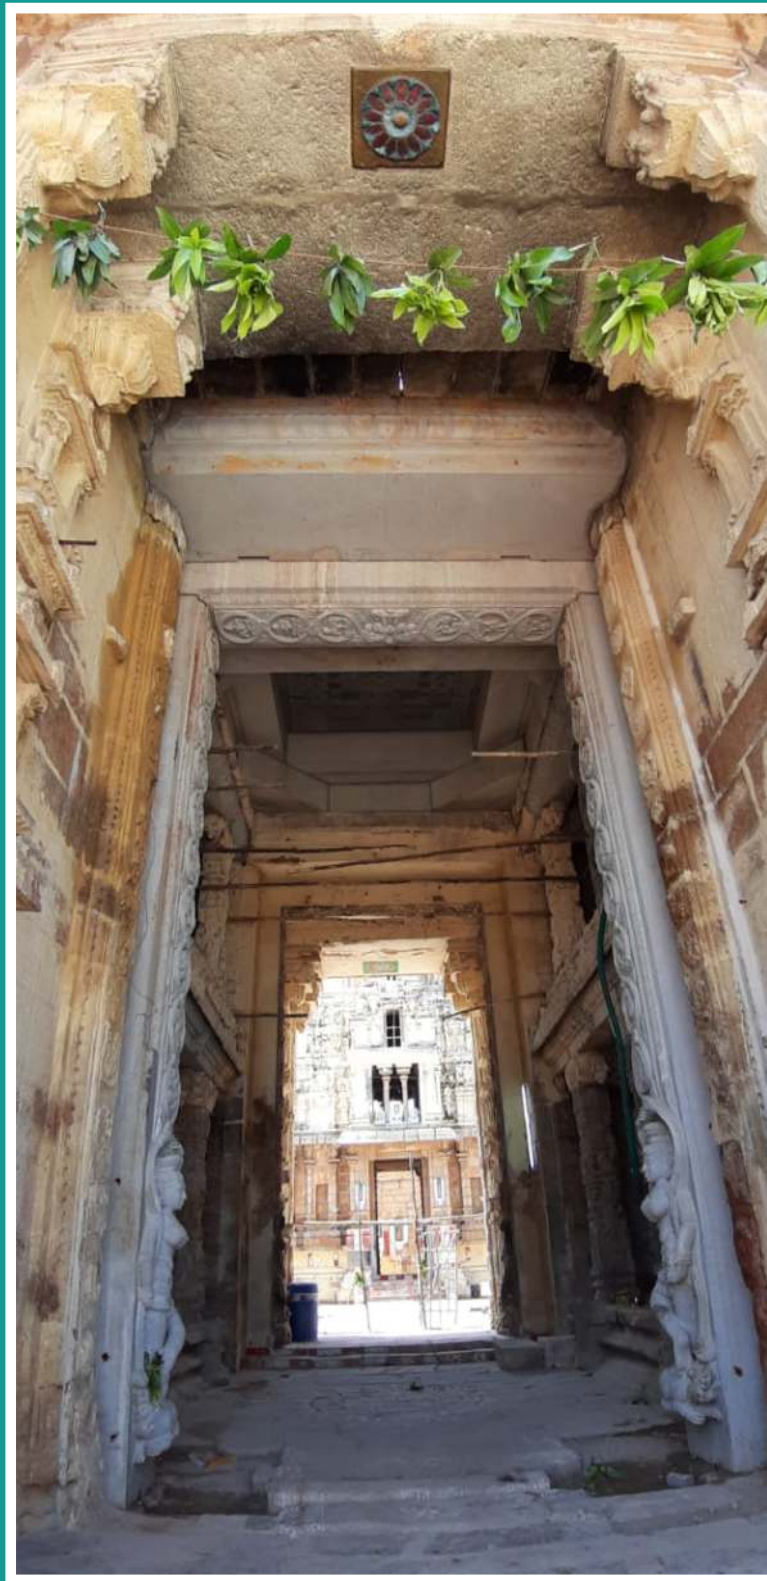
After Thiruppani - Rajagopuram Main Entrance

After installation of the new door frame, the original Grandeur of the Rajagopuram entrance is restored.

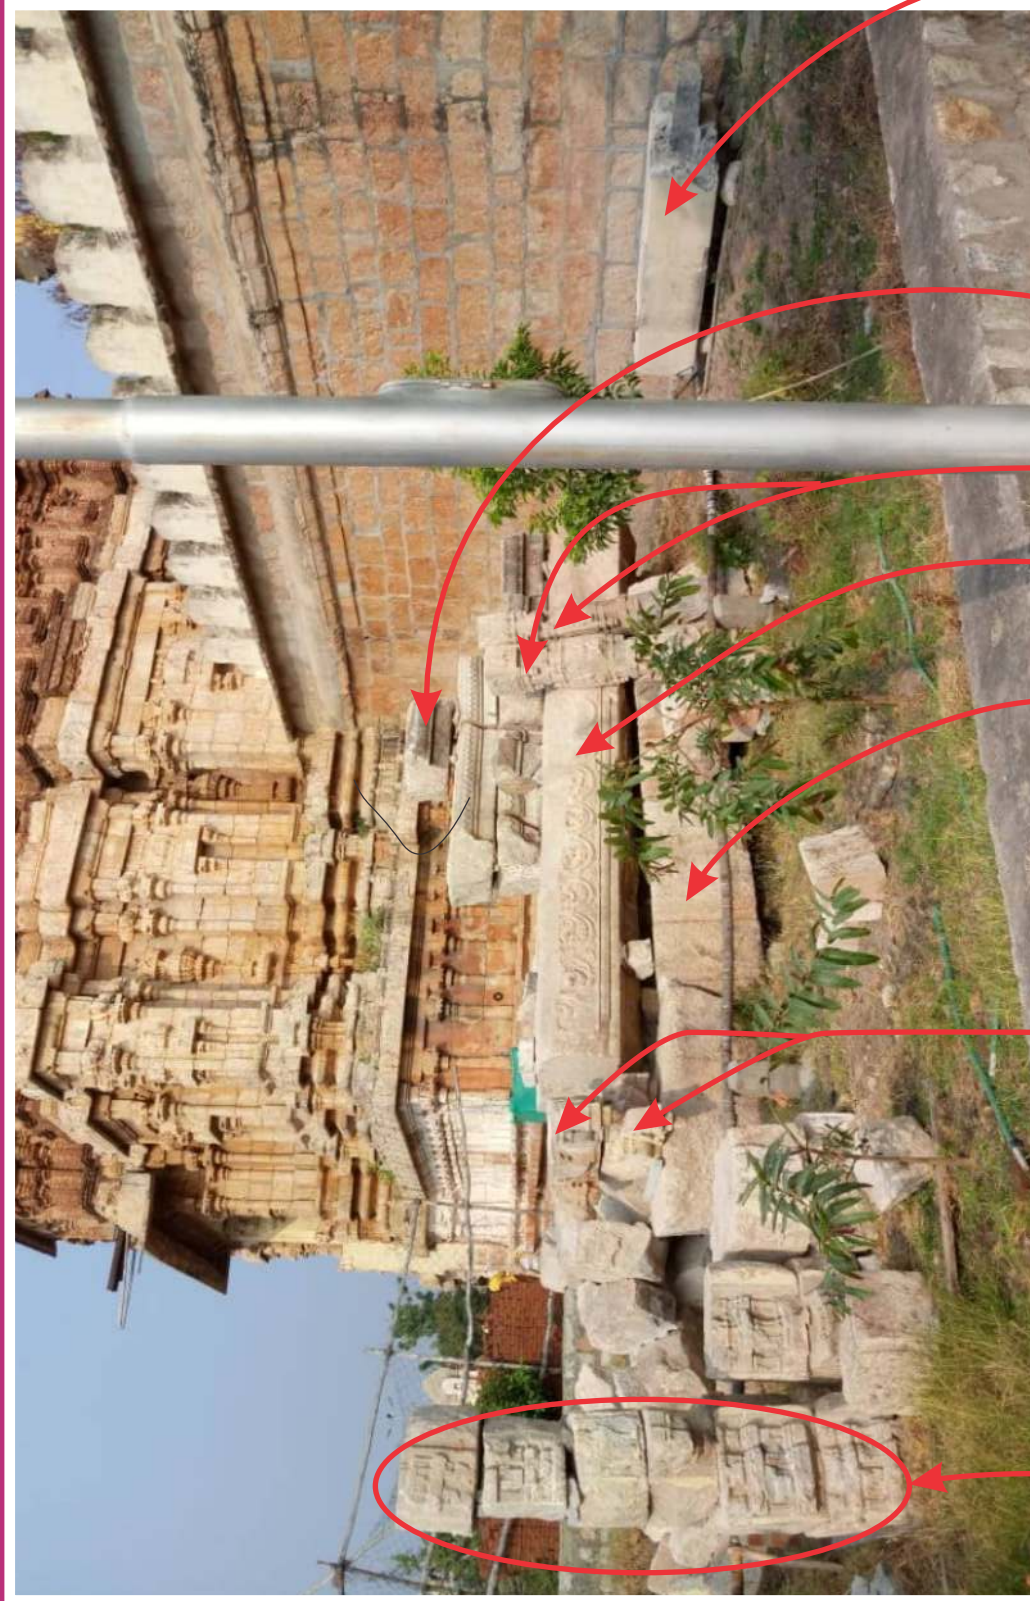
Temporary Granite wall supporting the cracked uthiram
