**Arulmighu Shree Pundarikatcha Perumal Thirukoil
RajaGopura Thiruppani**

REPORT - 4 (Feb 2014-Dec 2017)

**Status report
and
compliance status relating to the
observations and recommendations made by the UNESCO Fact Finding Committee**

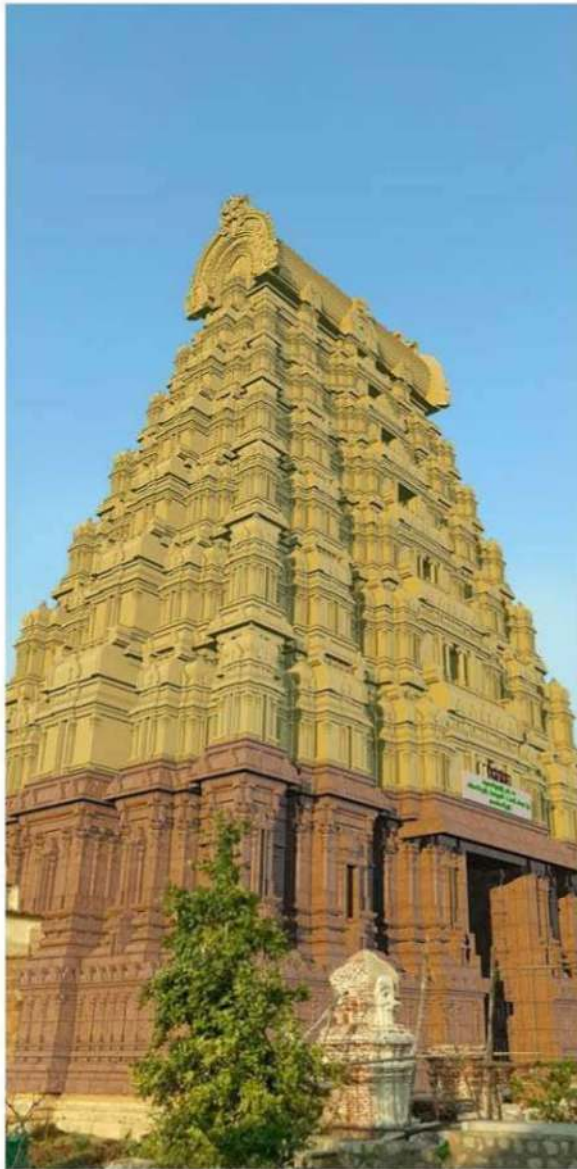
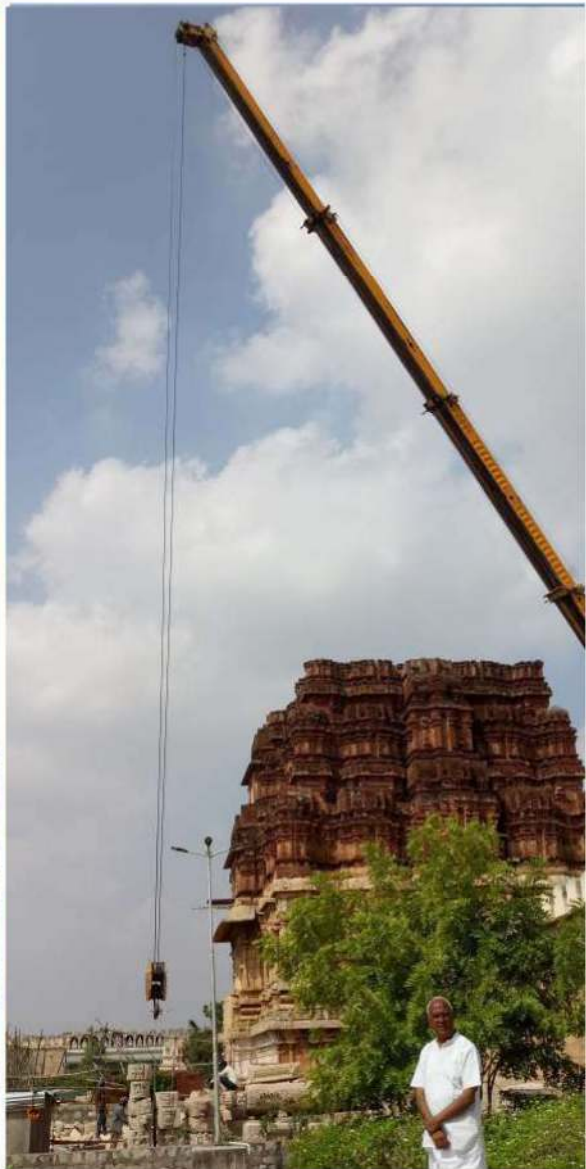
Computer generated view of the RajaGopuram is shown in comparison with the existing RajaGopuram

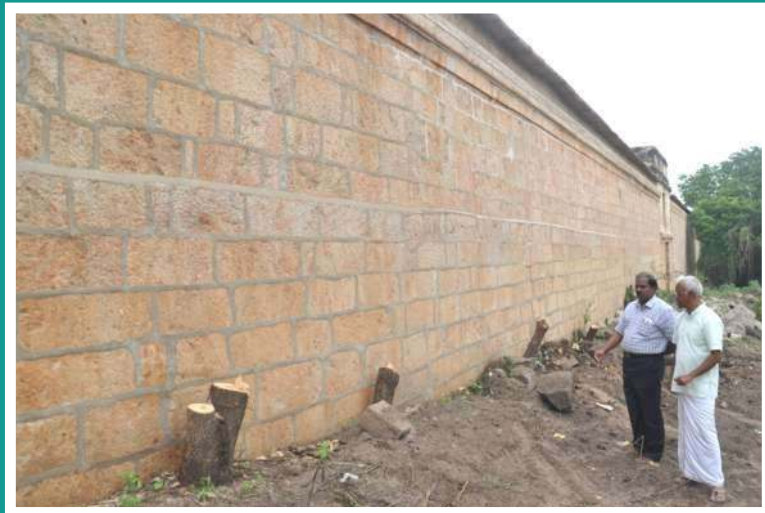
*Huge trees have grown along the compound causing concern - Jan 2015
Sri Rangam Joint Commissioner Shri. P. Jayaraman inspecting*

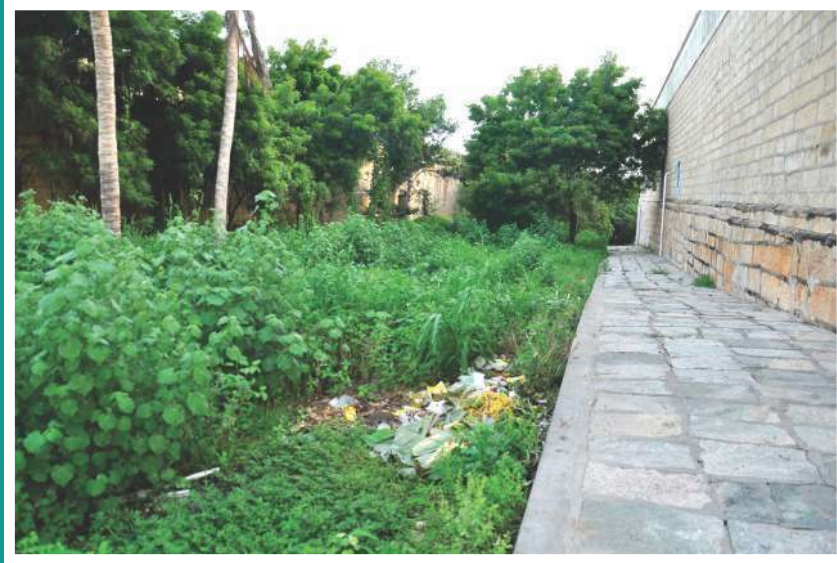
Eastern prakaram - Before renovation Aug 2014

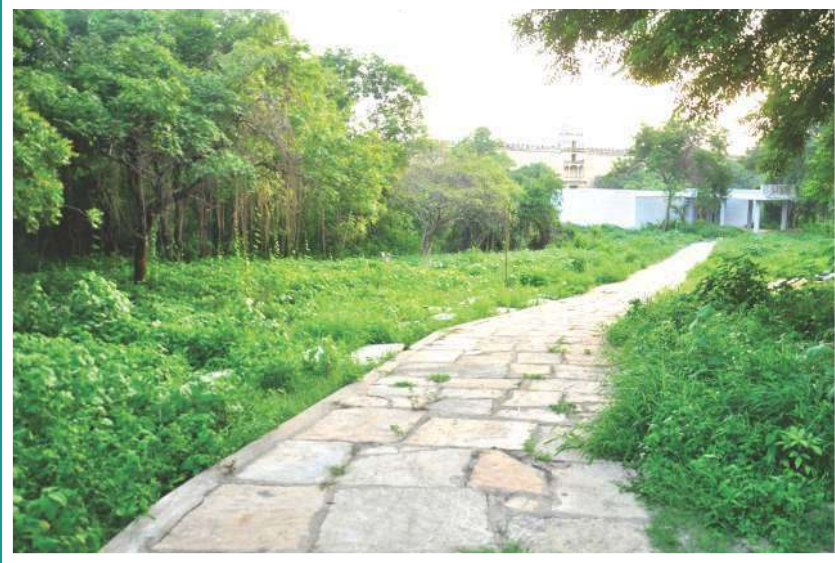
South east prakaram - Before renovation Aug 2014

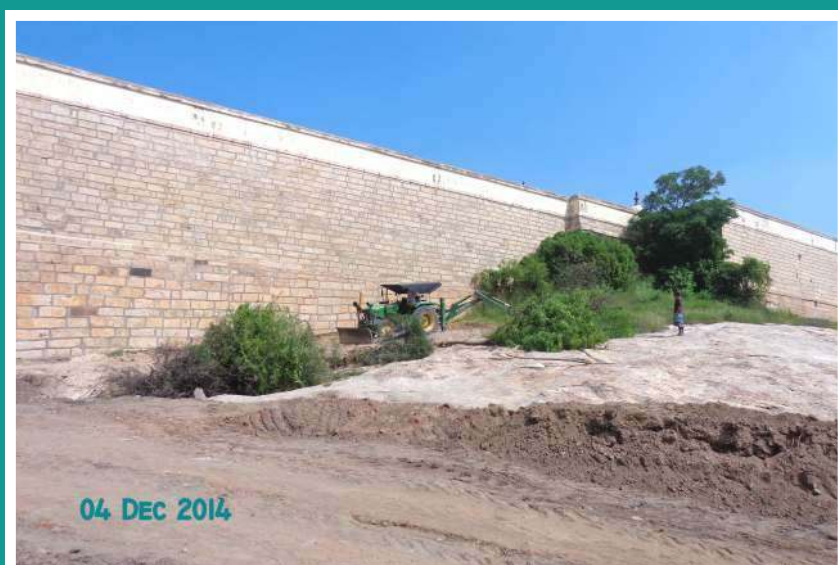
Enough and more vegetation including trees grown close to the compound - Dec 2014

After renovation Jul 2016 - The trees were removed

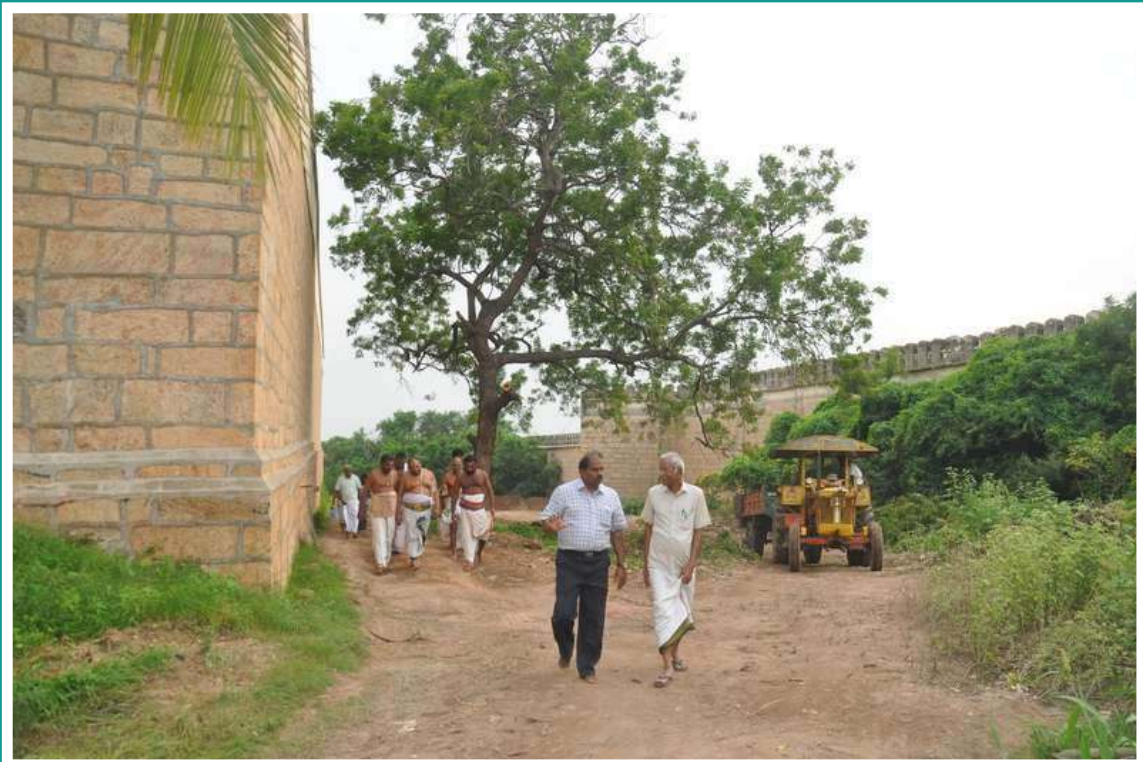
Sri Rangam Joint Commissioner Shri. P. Jayaraman inspecting - Jan 2015

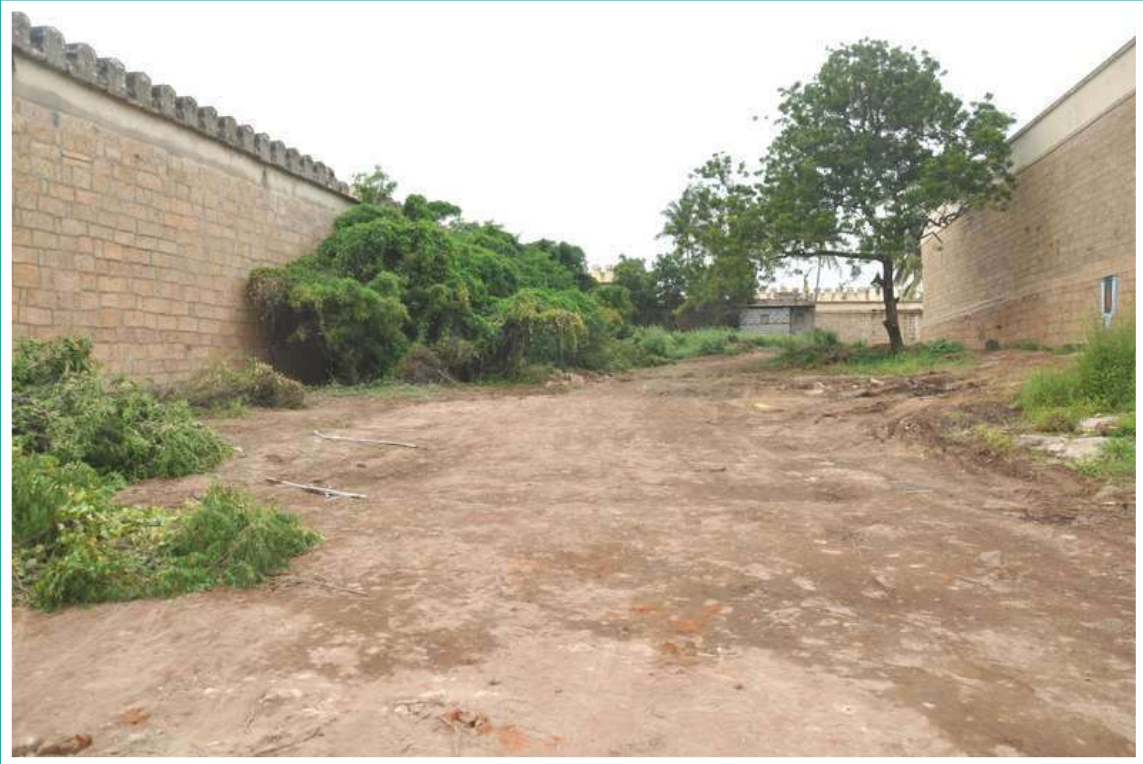
Too much of vegetation near the compound - Feb 2015

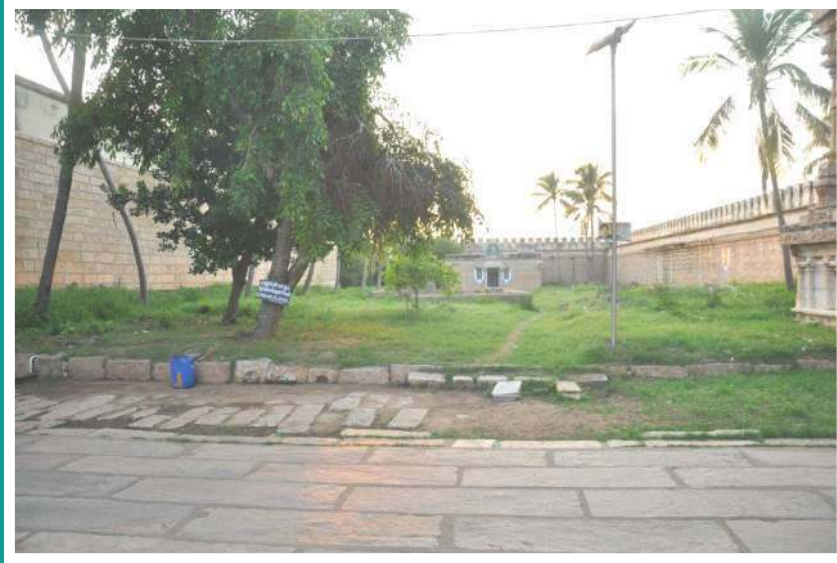
North prakaram - Before renovation Aug 2014

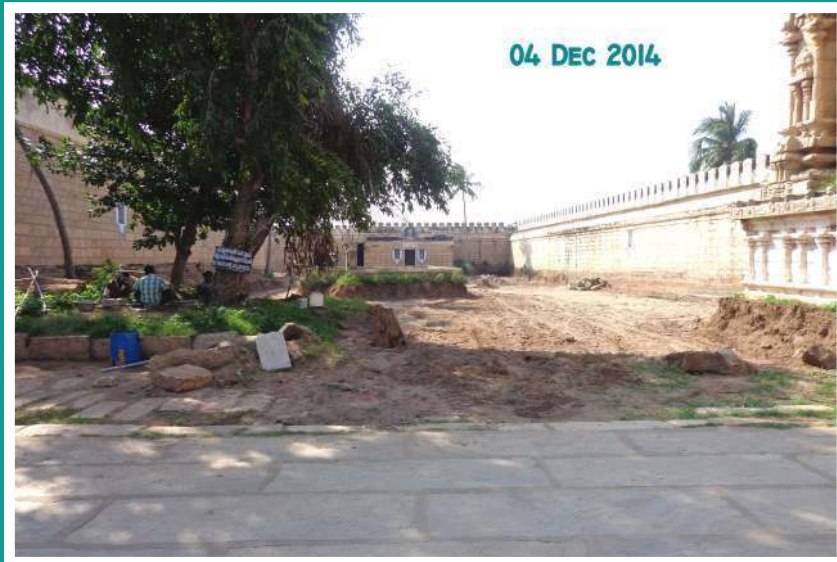
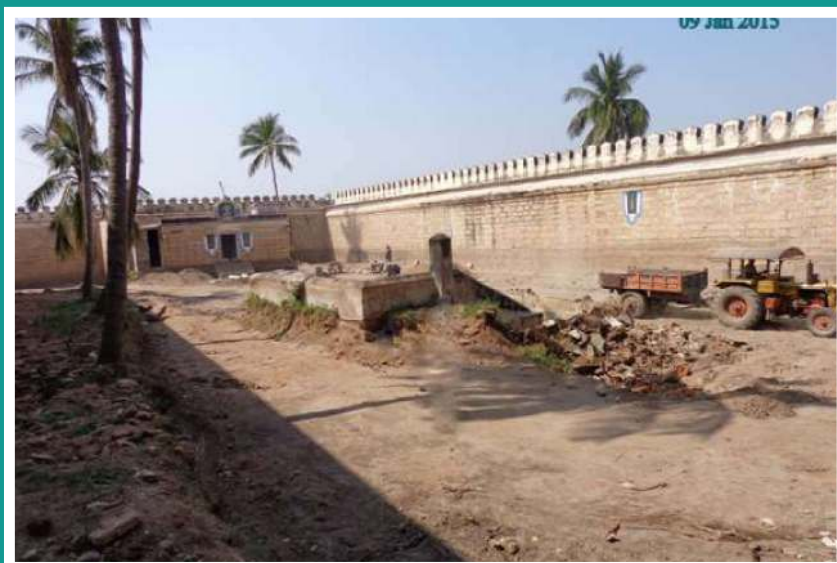
North prakaram - During renovation Jan 2015

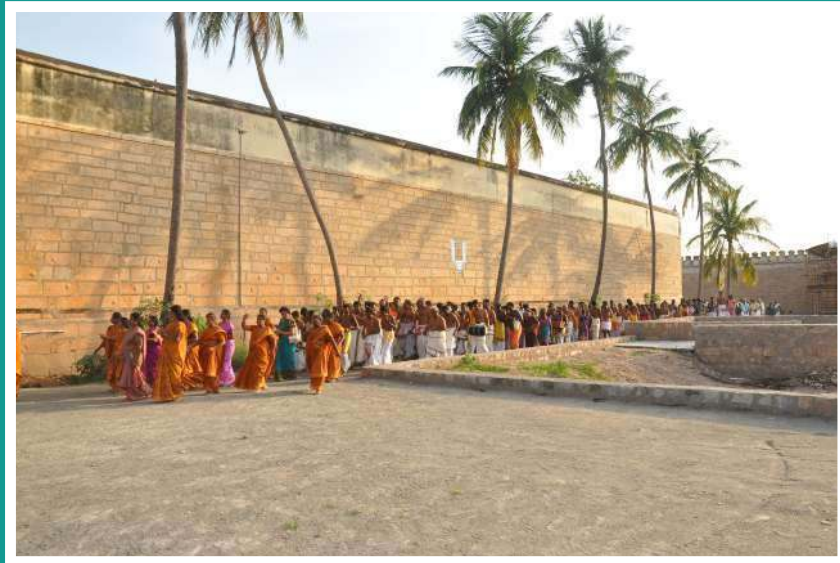
*Coconut trees closed to the compound wall have been removed - May 2015
10 Nos. New coconut saplings were planted in the south*

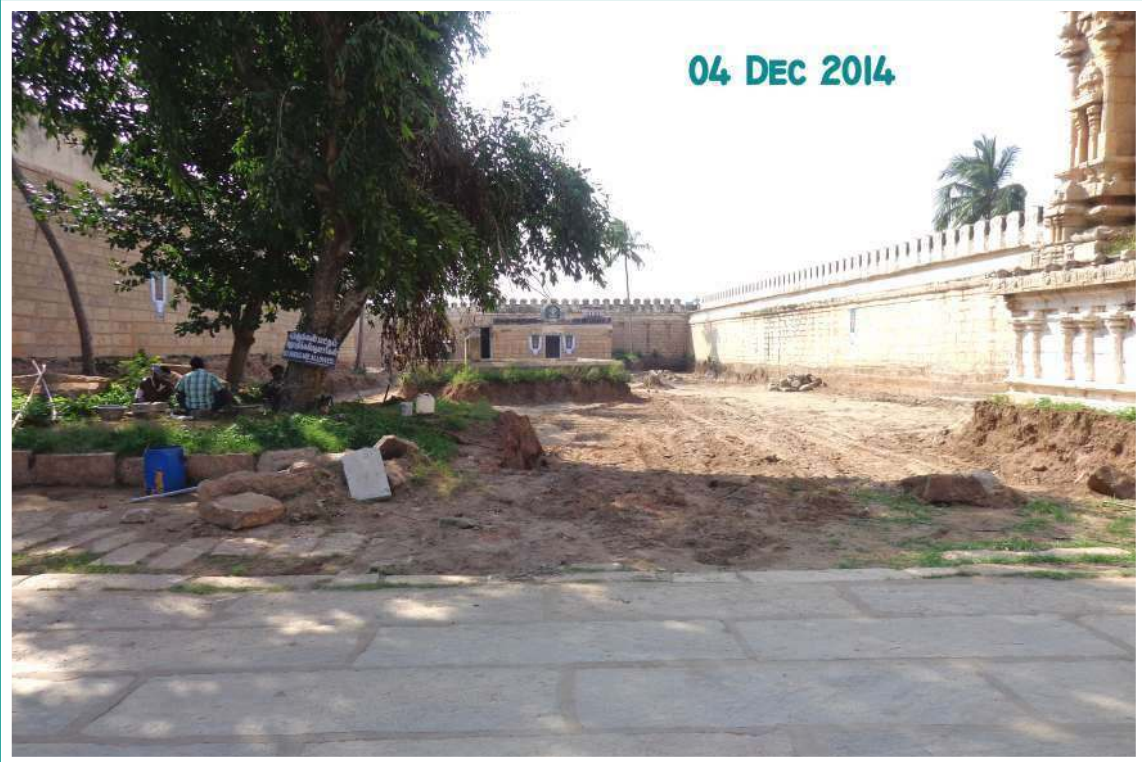
Manavala Mamunigal Sannidhi Dec 2014

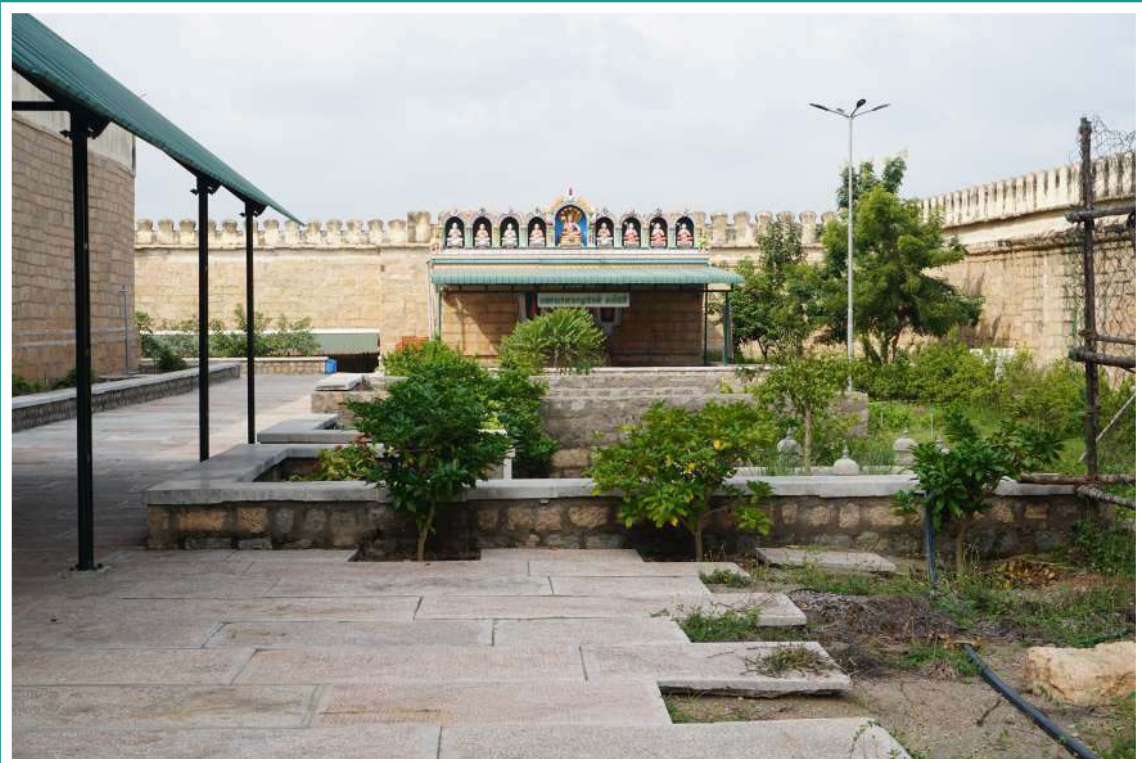
Manavala Mamunigal Sannidhi After renovation Dec 2016

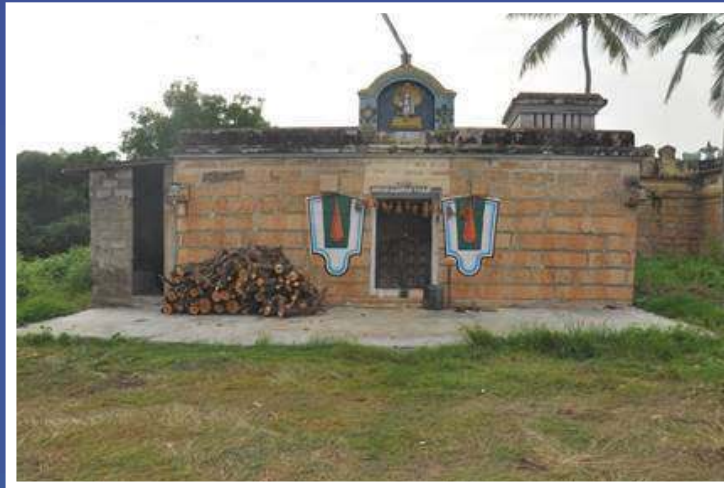
Before renovation

We took up the renovation work at SRIMAN MANAVALAMAMUNIGAL sannidhi, conducted the samprokshanam on 13th November 2015.

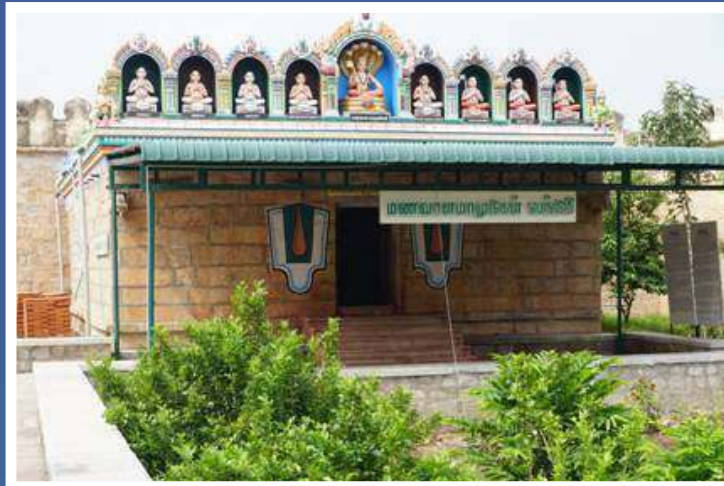
After renovation

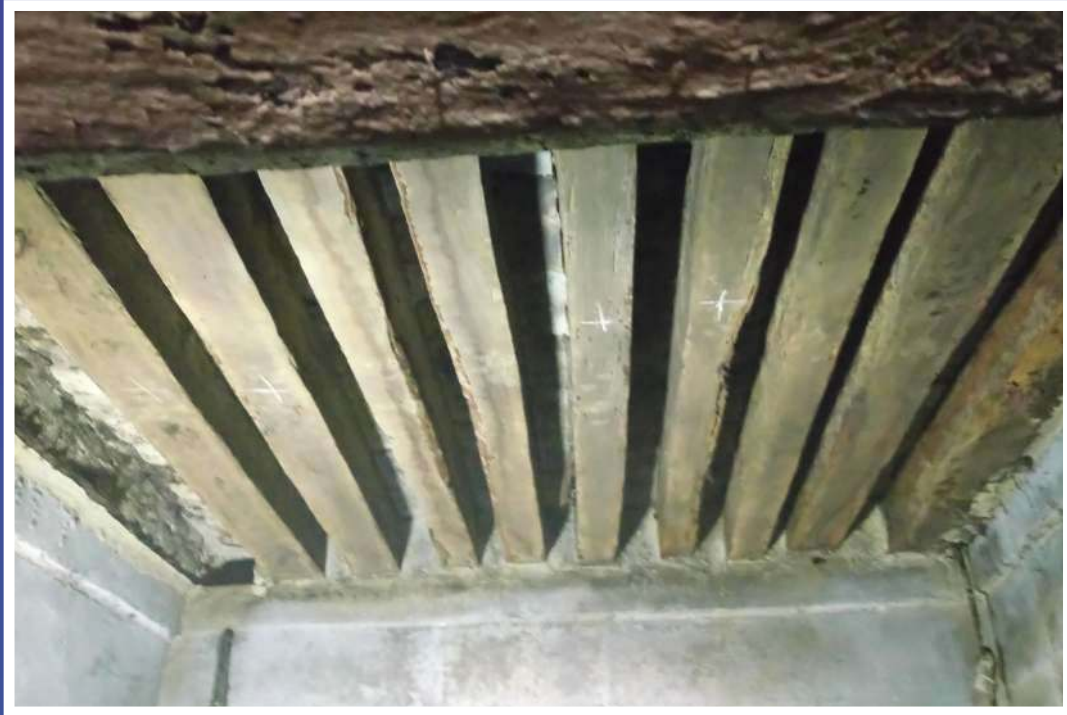
Deteriorated ceiling in the sanctum santrum - May 2016

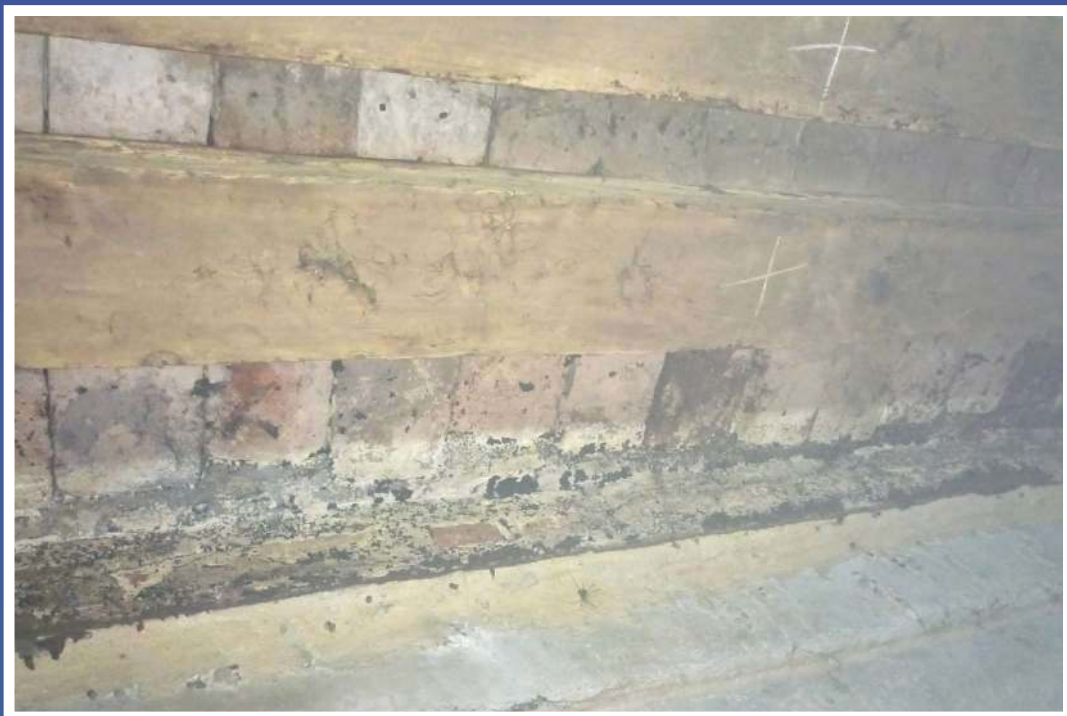
Deteriorated bricks ceiling in the sanctum santrum - May 2016

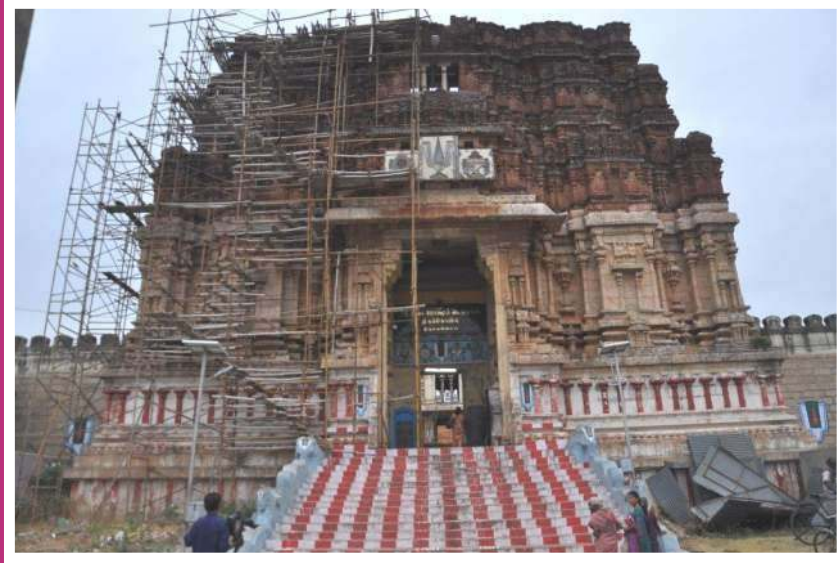
*Northern Entrance - 18 steps
representing 18 chapters of Bhagavat Gita*

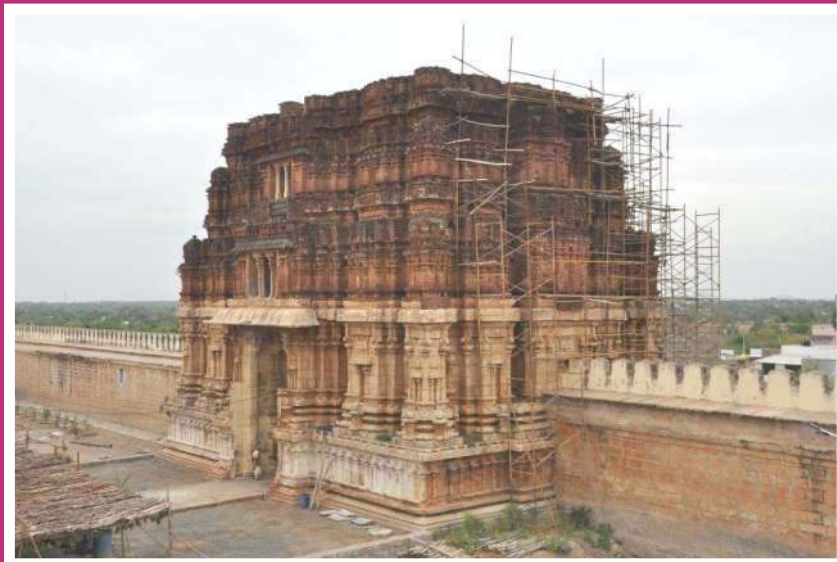
View of the Raja Gopuram from Northeast side of 4th prakaram

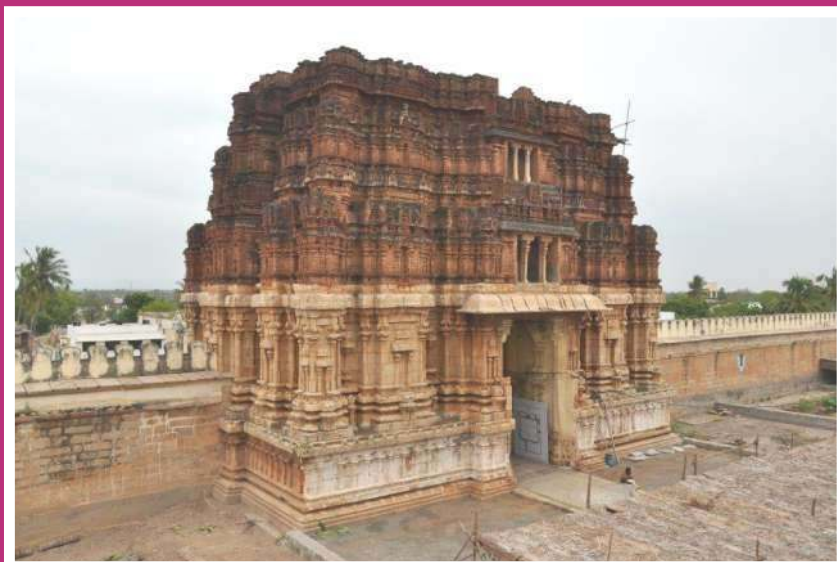
View of the Raja Gopuram from Northwest part of 4th prakaram

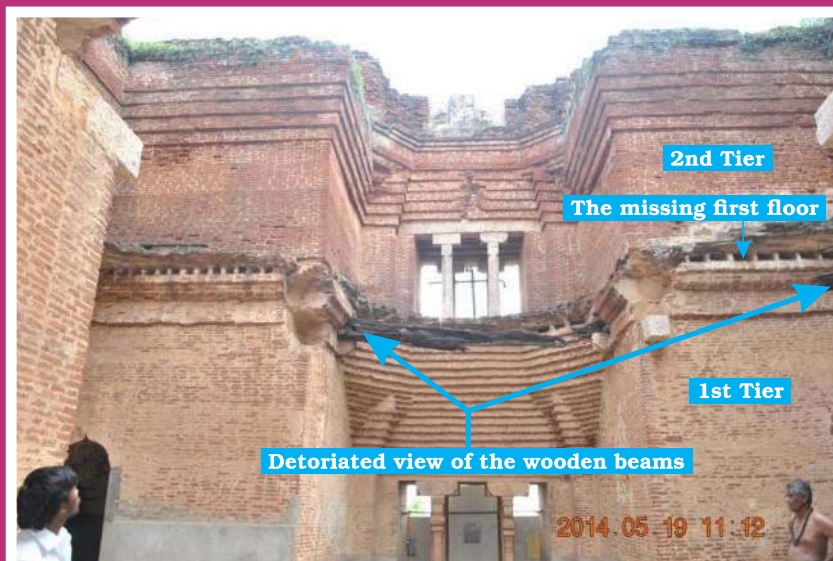
View of the Raja Gopuram from inside. First floor - Northern entrance

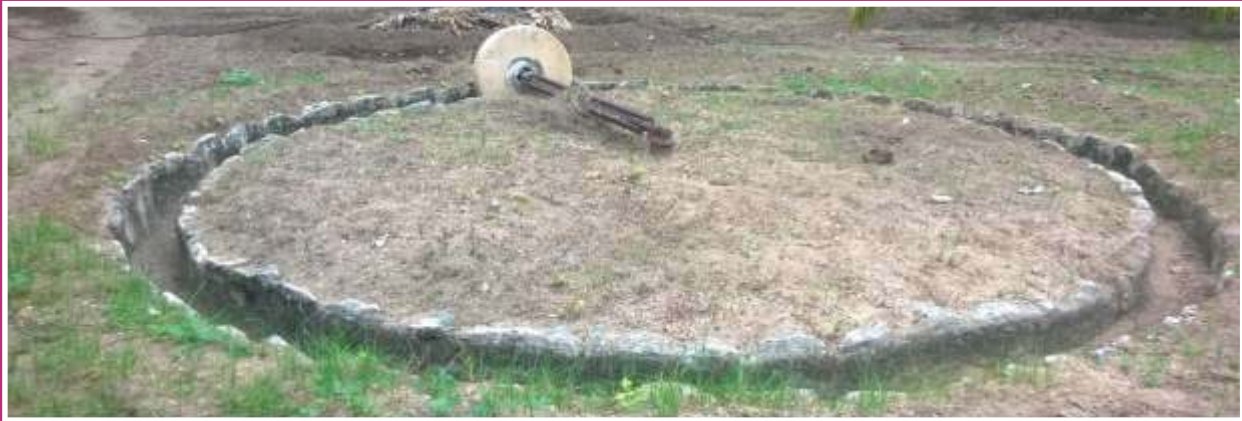
Traditional method

In the traditional process the granite roller what is seen in the picture is driven by two bullocks traveling in a circular path, enabling the grinding of the lime and sand mixture with the addition of water.

In these modern times, we wanted to bring a little mechanization to replace the bulls by the introduction of the gearbox in the middle of the circle, with the granite rollers on either side to prepare the Lime-Mortar.

After the studies, we have found the different techniques available. Here we have decided to pursue as per the good old technique of utilizing the bulls to traverse in the circular path to grind. During the design of this machine we have estimated that it may take about a minute for the bulls to complete one full circle. That is 1 rpm. Therefore, in consultation with the manufacturer Shri K Kandasamy, Sakthi Drives - Coimbatore, it was decided to design the suitable gearbox to reduce the speed from the regular 1440 rpm to 1 rpm with the suitable other parts. Here the introduction of the two grinding wheels diagonally opposite became mandatory to balance the system. By this process we get an added advantage that the grinding time can be reduced by 50%.

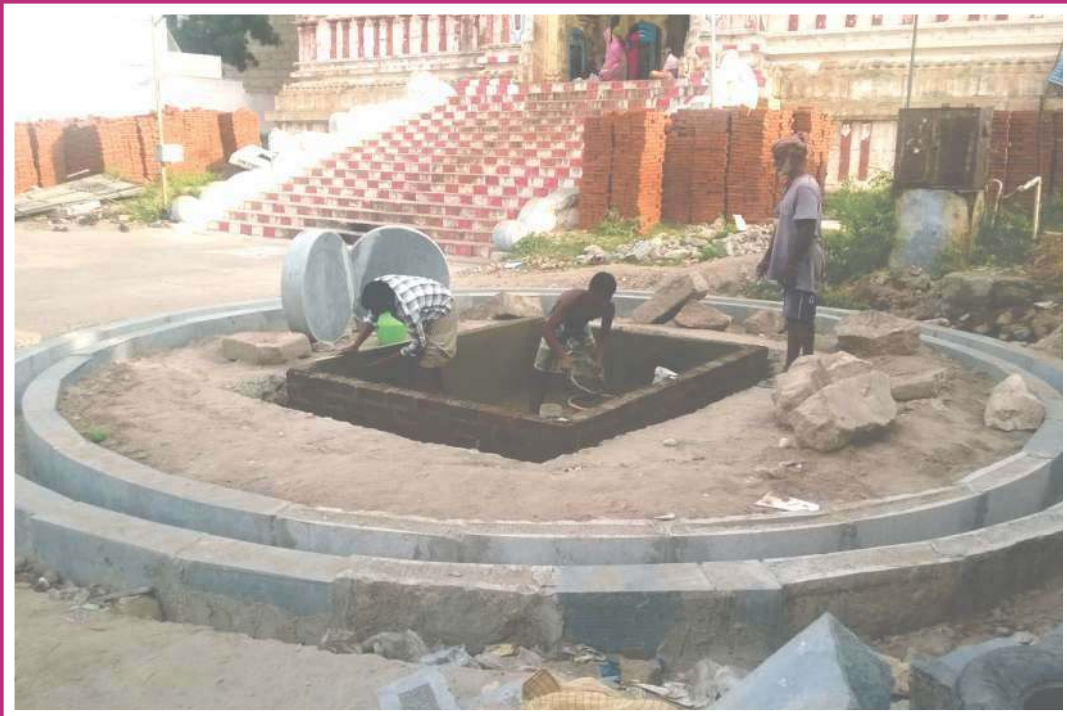
Traditional Lime-Mortar preparing arrangement in construction phase

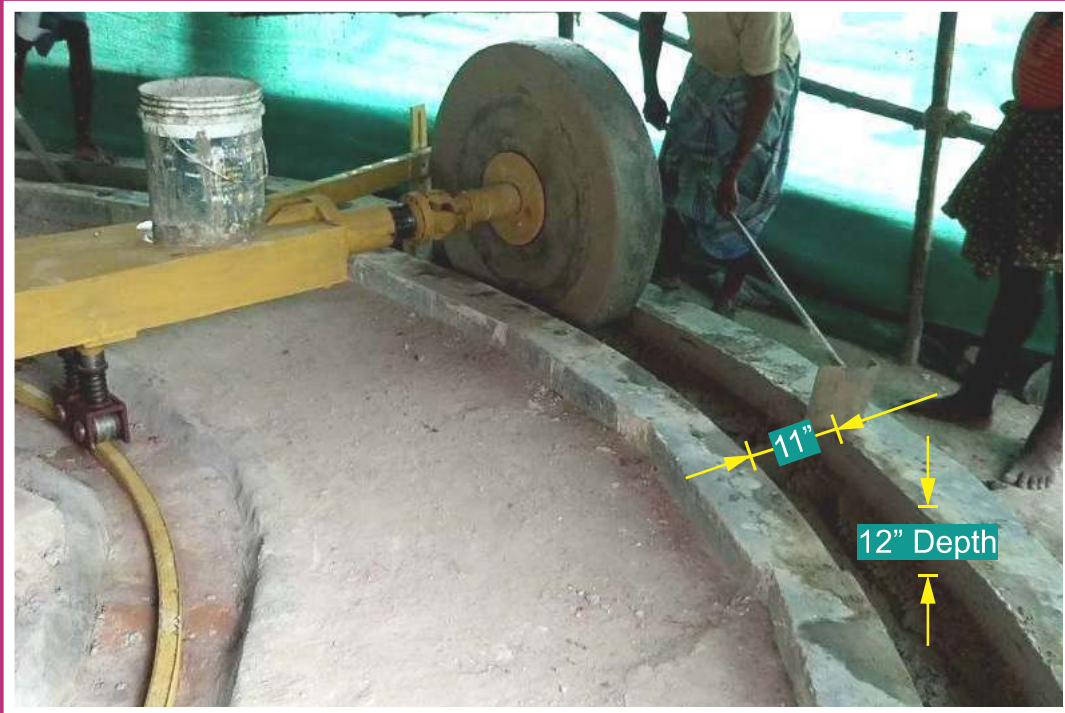
Another view of the Lime-Mortar mixer

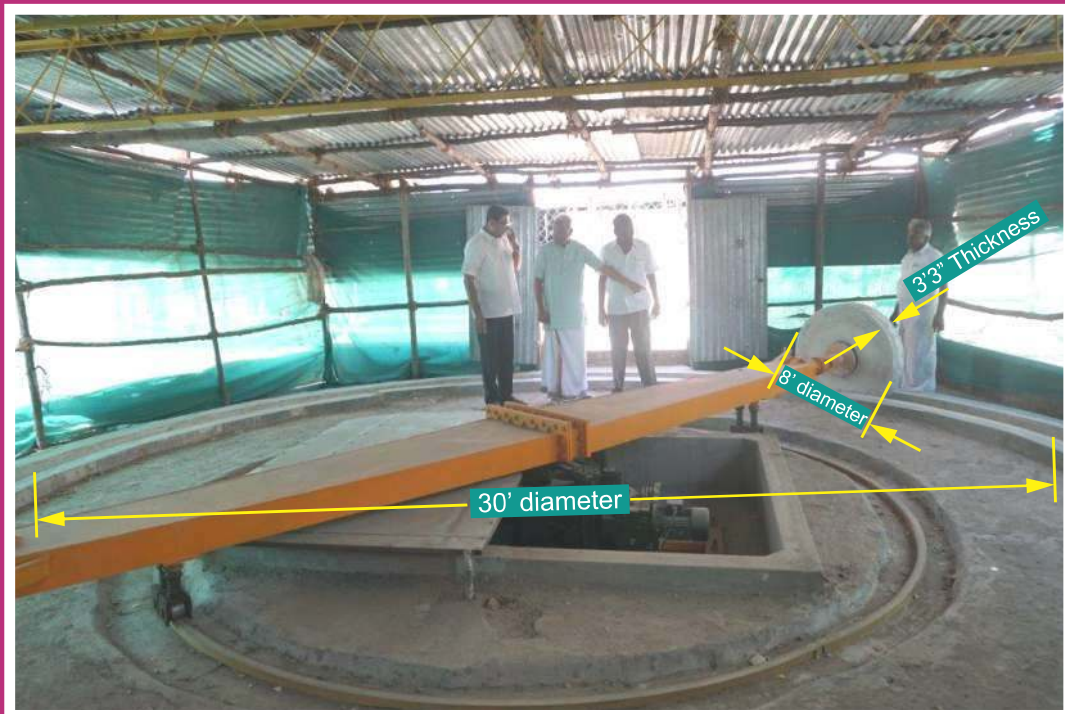
Dr. Arun Menon - IIT Consultant, Mr. V S Jayabal - Donor and Mr. Kumragurubaran - Sthapathi discussing a Lime-Mortar mixer arrangement

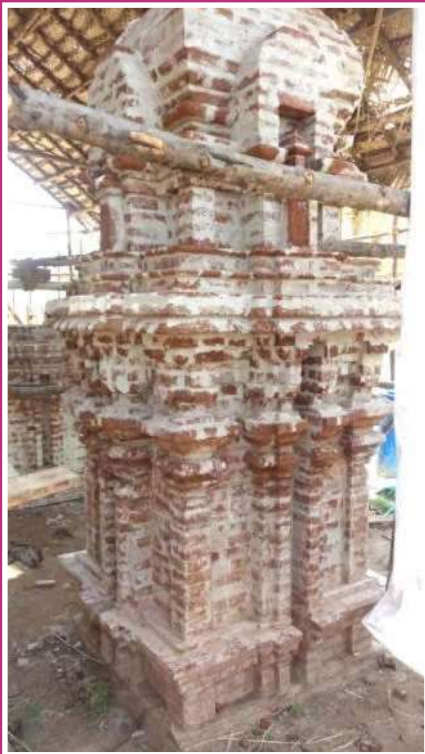
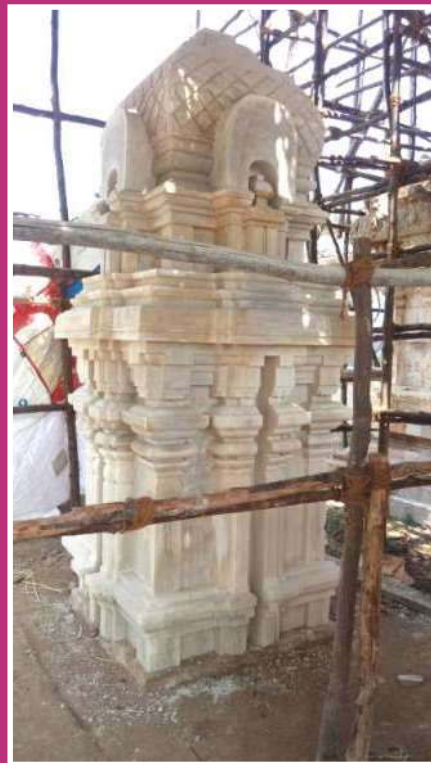
To confirm the quality of thus prepared **Lime-Mortar** model Gopurams were built in the fourth prakaram adjoining the Raja Gopuram. For this purpose we have chosen the **karnakudu** from the first (5' x 5' x 12' height), second and the third tier to the actual dimensions.

This was completed in Jan 2017. On the four sides of the karnakudu, we have plastered with the Lime-Mortar on two sides and left the two sides with the original brick structure. This will give an idea about the complications / intricacies of the structure to the common devotee. This can also be time tested.

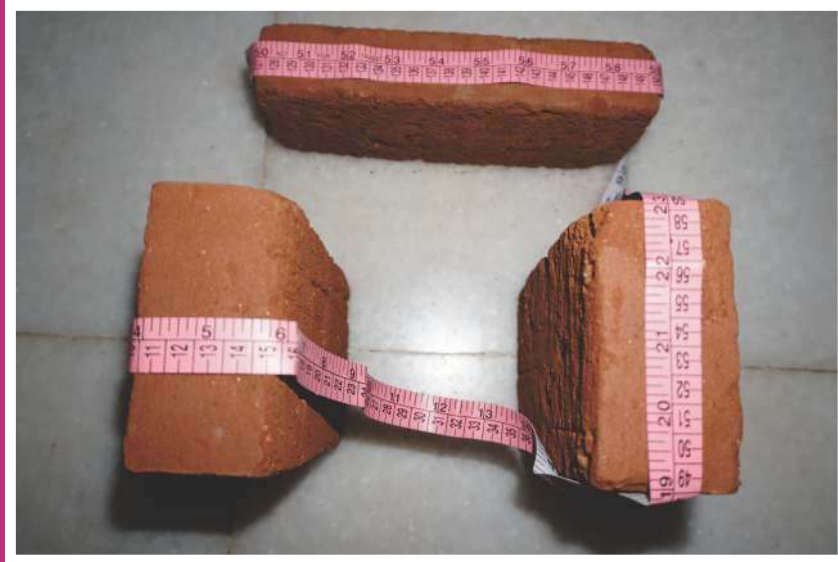
Picture of the bricks with measurements

The conventional bricks is about 3 inches thick. Therefore, the machines were modified to produce the bricks with 2 inches thickness, close to the existing bricks.

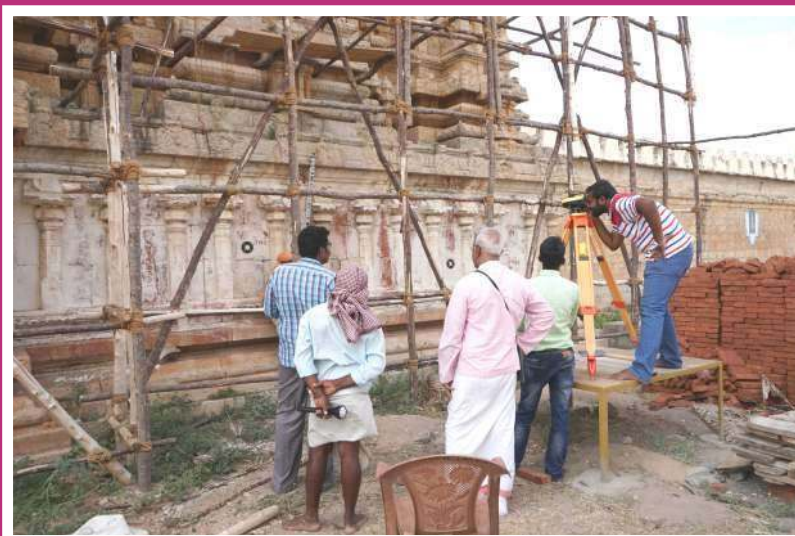
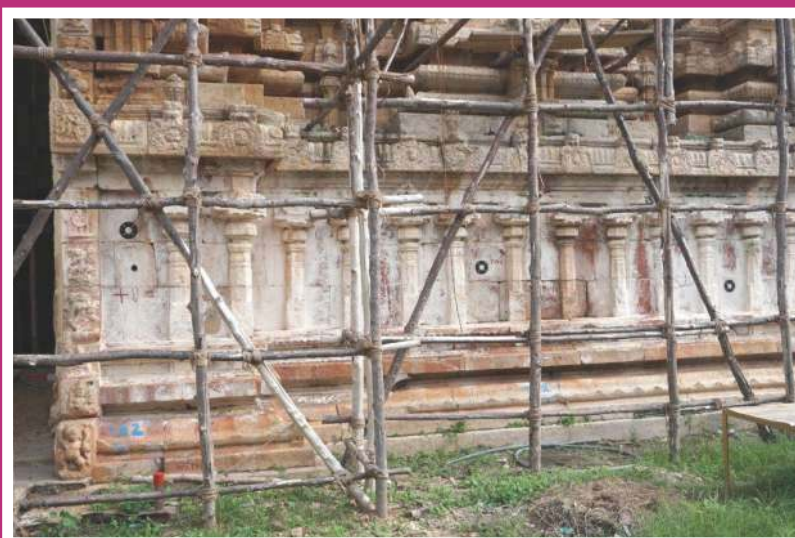
SHM will ensure safety of the technical personnel and labour during investigation and execution, and will provide necessary indication of an acceptable levels of structural movement. Crack width gauges are also installed.

Encardio Rite Electronics Pvt Ltd, Lucknow has installed the necessary meters in April, 2017. Periodically parameters are recorded and reported to assess settlements, deflections and inclinations if any.

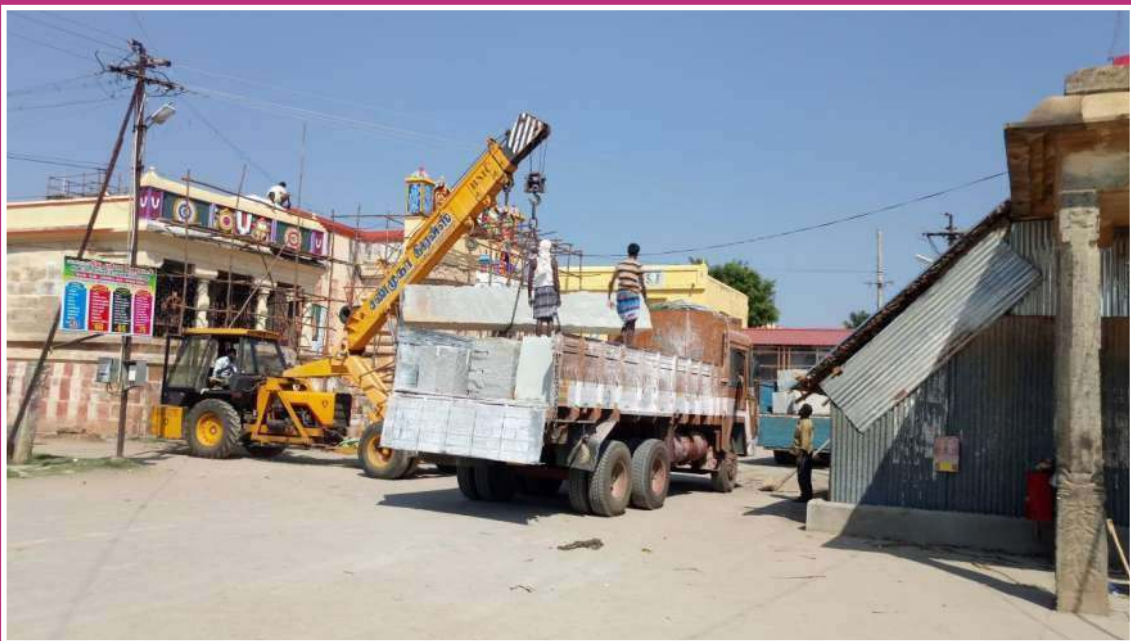
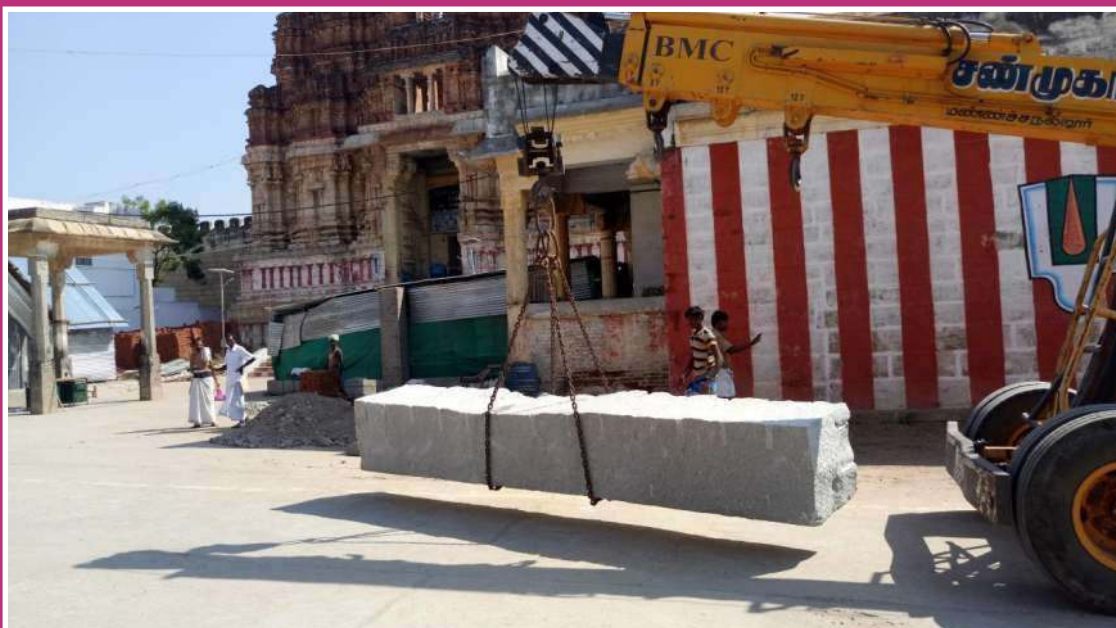
The first set of beams arrived at the temple on 9 Feb 2017

Based on the interim report on the **IIT-M** it was decided to replace three pillars and nine beams in the entrance.

Hence we have ordered and received 18 nos. Granite Beams & Pillars, approximately 95 MT from the regions around Bangalore were brought in to replace the damaged Pillars & Beams. This also includes few extra beams, in case if any of them breaks in the installation process.

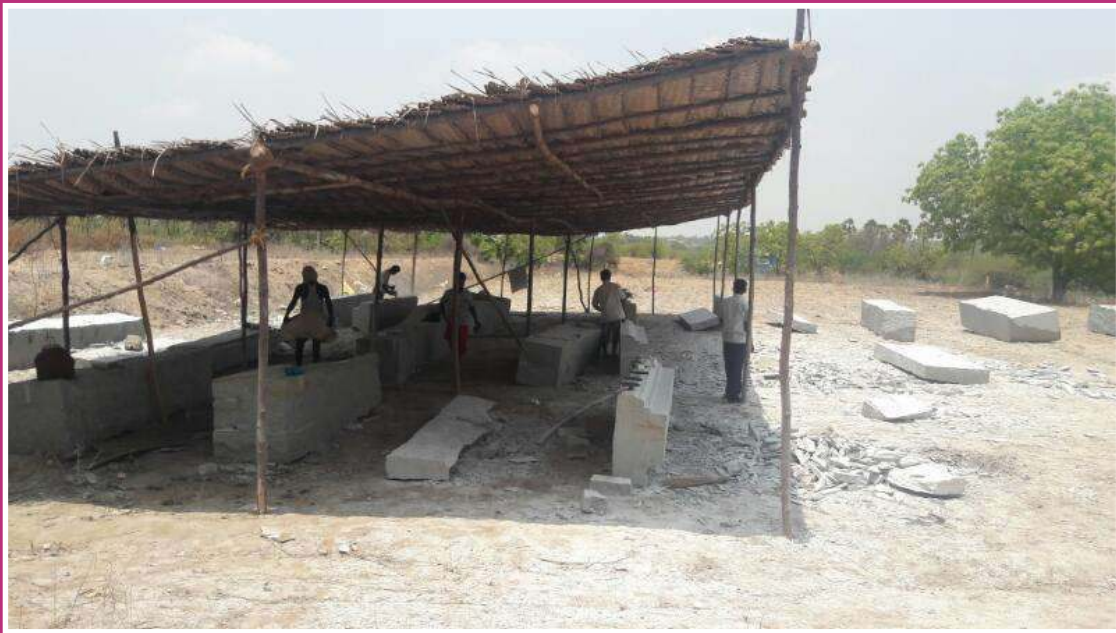
Work in progress

The team of sculptors are working on this beams Since, 4th of Apr 2017,
We hope to complete this work by Nov 2017.

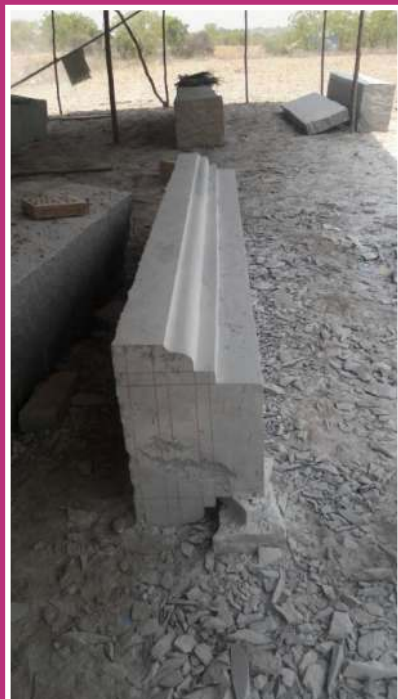
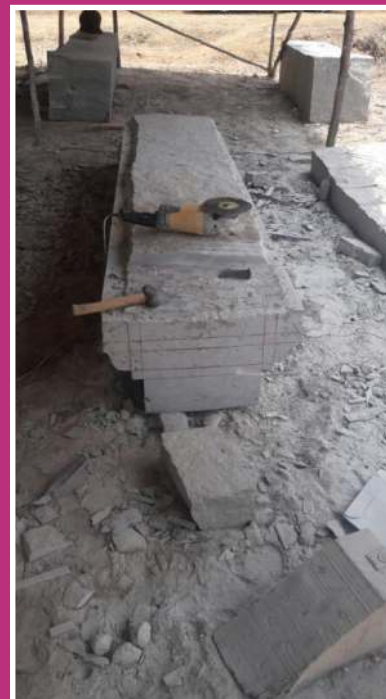
Strengthening the Kalkaram

Yet another major recommendations given in the **IIT-M** report is to strengthen the kalkaram by injecting the Lime-Mortar slurry at random locations.

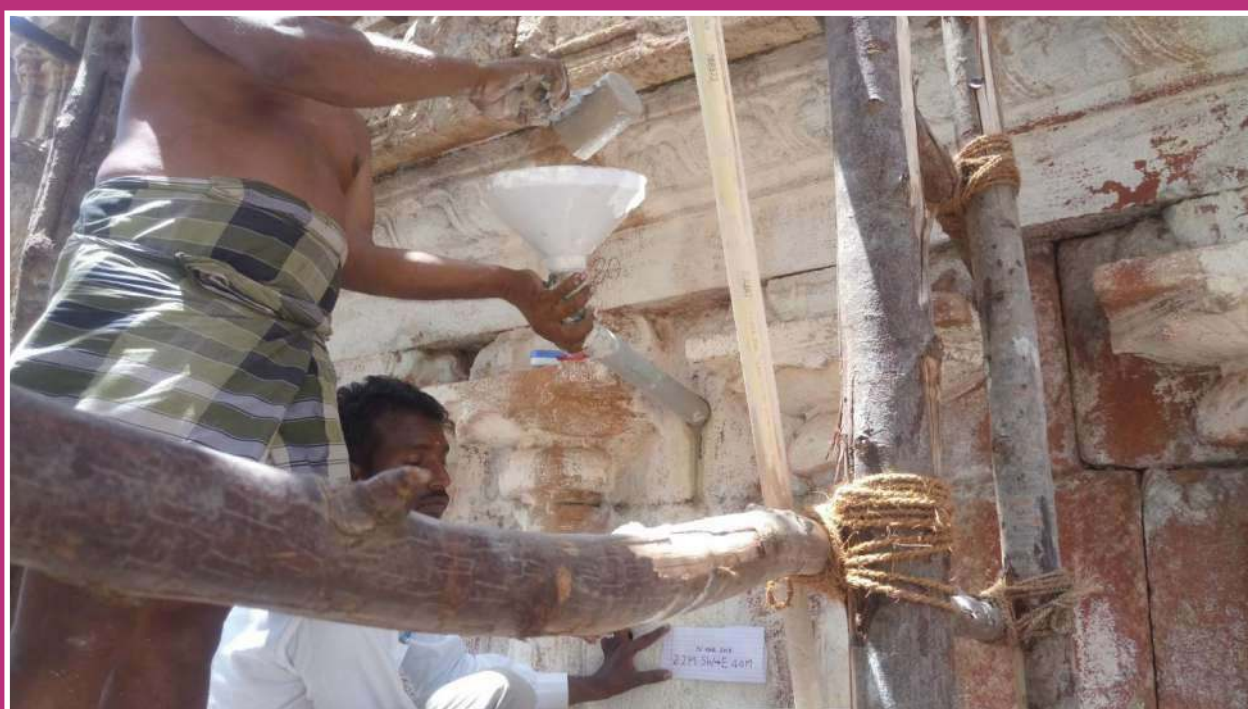
Injecting the Lime-Mortar Slurry

This process was carried out in Apr 2017.

In this process, after analyzing all the Core-cut samples, probably we could understand that double-leaf construction techniques were used to build the Raja Gopuram of this size seems a normal practice. The granite stones thickness being at least 300-400 mm on both the sides, inside filled with broken stones and Lime-Mortar.

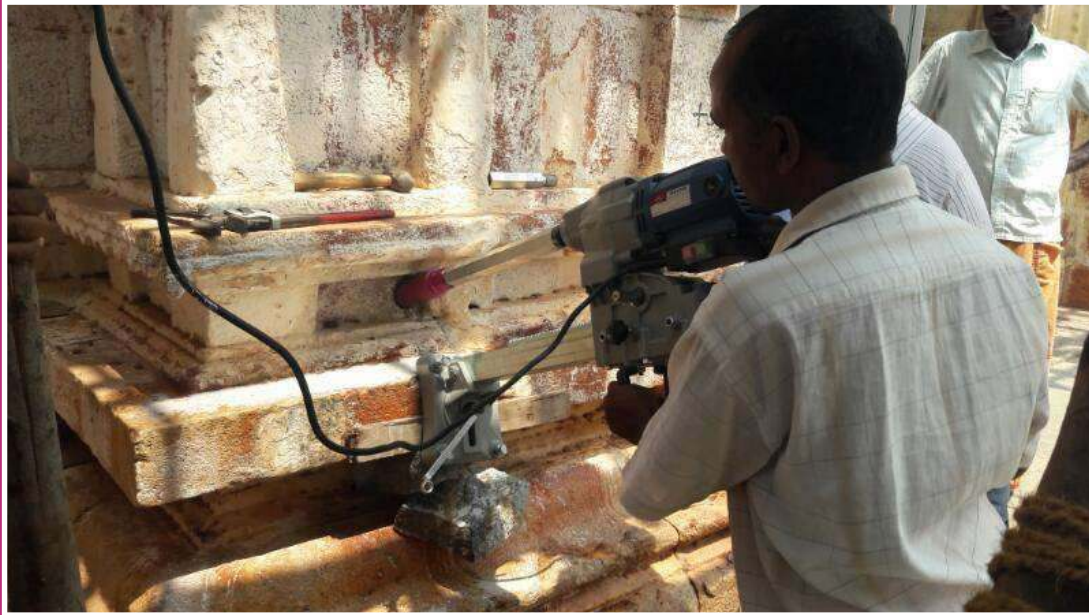
Core drilling in progress
