**Arulmighu Shree Pundarikatcha Perumal Thirukoil
RajaGopura Thiruppani**

REPORT - 4 (Feb 2014-Dec 2017)

**Status report
and
compliance status relating to the
observations and recommendations made by the UNESCO Fact Finding Committee**

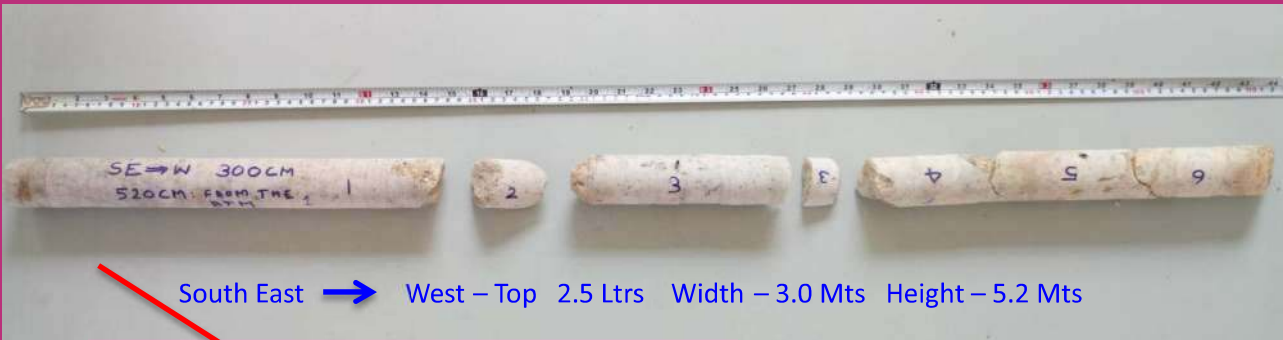
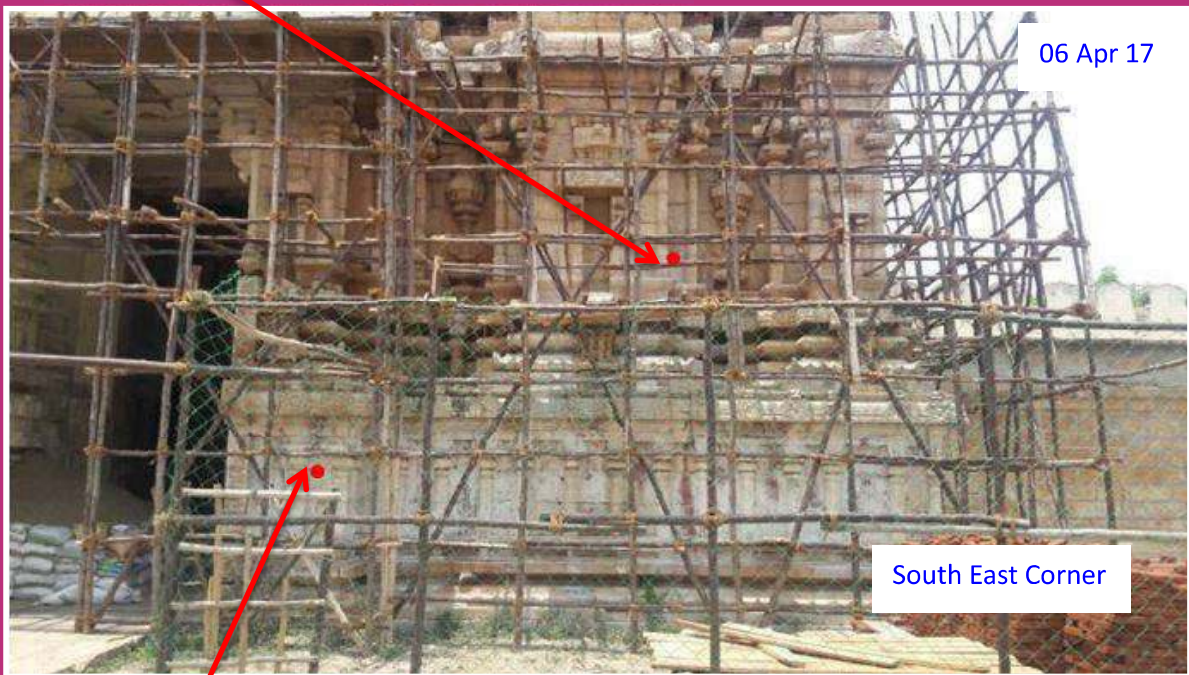
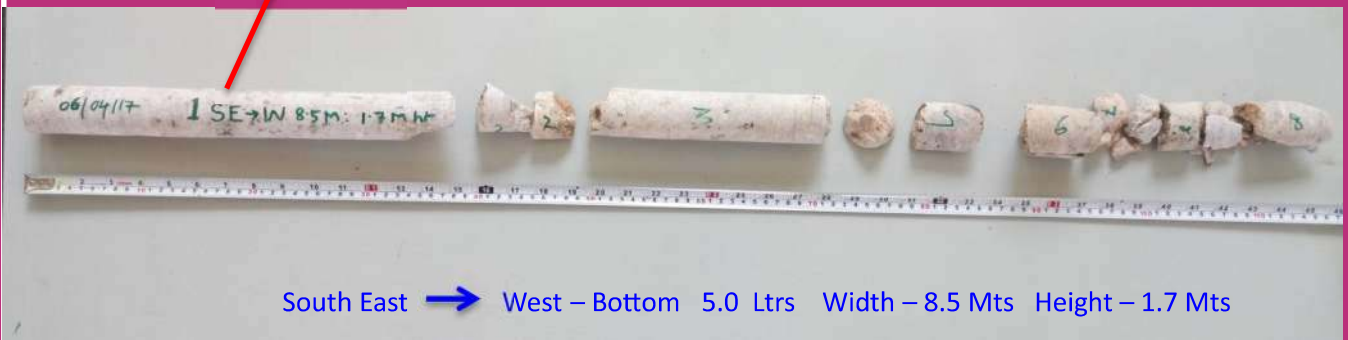
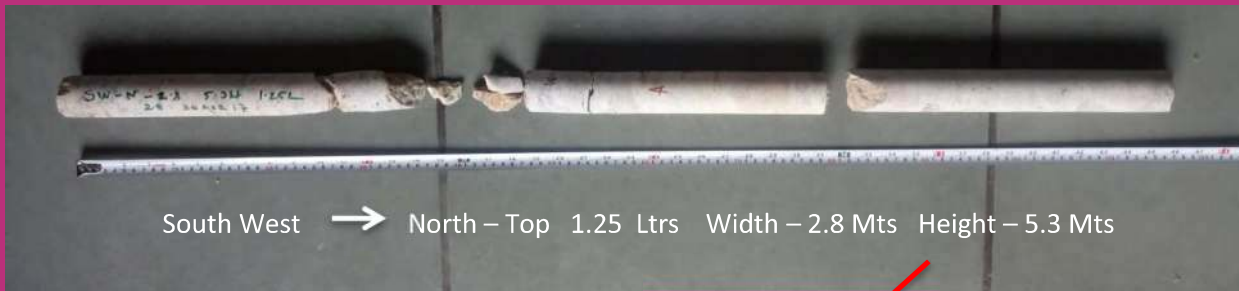
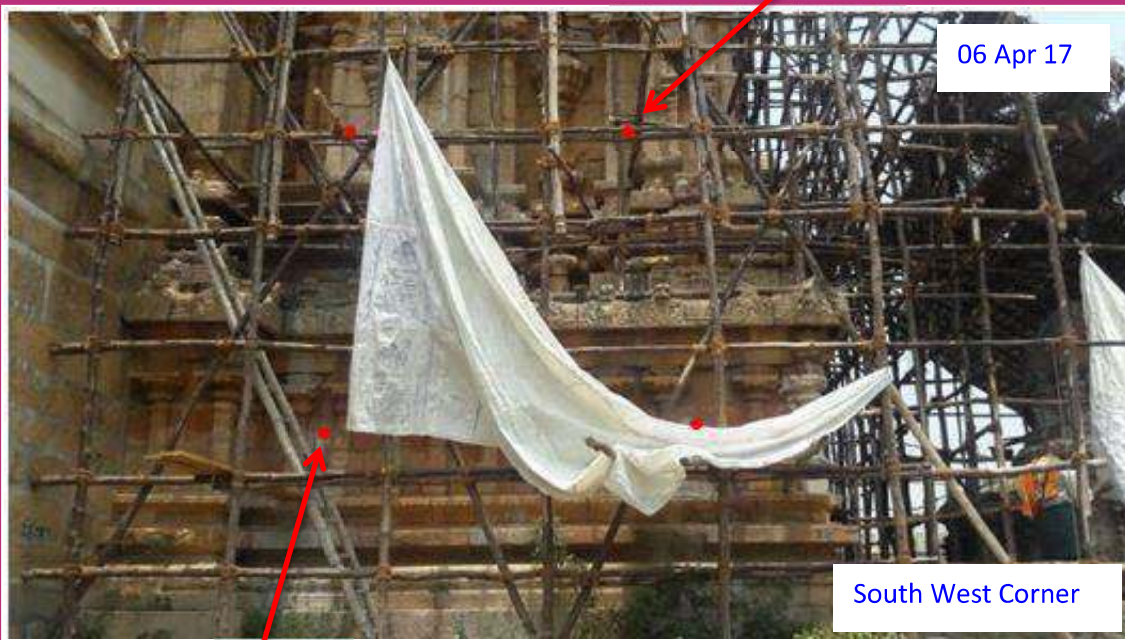
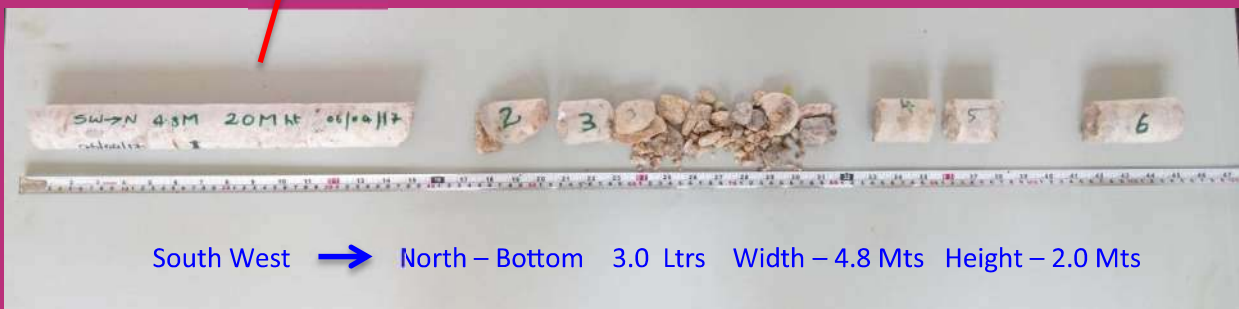
Location Deals of the Grouting Points

SNo	Location - Side	Qty Litre	Width Meter	Height Meter
1	South West -North – TOP	1.25	2.8	5.3
2	South West -North – TOP	3.5	4.2	5.3
3	South West -North – BOTTOM	3.0	4.8	2.0
4	South West -North – BOTTOM	5.5	1.1	2.0
5	South West -East – TOP	4.0	1.2	5.0
6	South West -East – TOP	5.5	4.0	5.0
7	South West -East – BOTTOM	5.5	1.0	1.7
8	South West -East – BOTTOM	9.5	4.0	2.2
9	South East-West – BOTTOM	5.0	8.5	1.7
10	South East -West – TOP	2.5	3.0	5.0
11	South East - North – TOP	3.0	1.2	5.4
12	South East - North – TOP	2.5	4.8	5.2

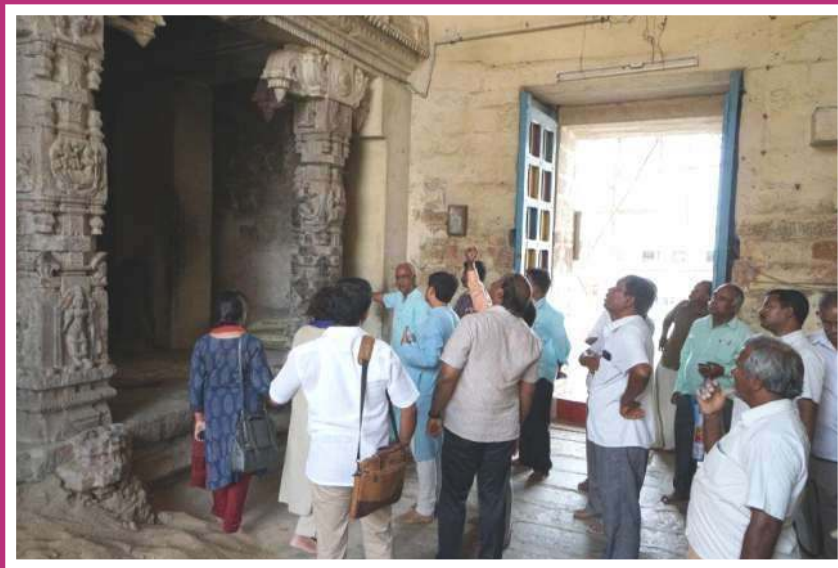
The team was mightily impressed about the procedure for Lime-Mortar preparation and the equipments used. Shri V S Jayabal was personally involved by explaining the team about the salient features that were being followed. They also reviewed the model gopuram and the feasibility report submitted by IIT-M.

UNESCO & ASI team inspecting

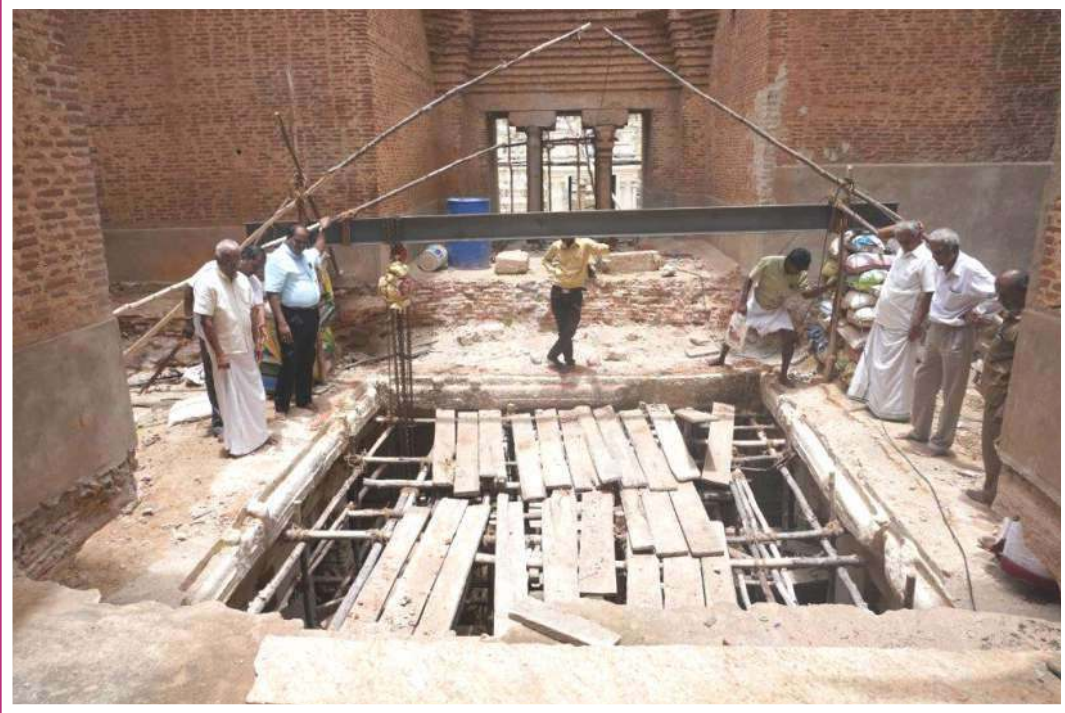
After removing the slab, we were surprised to see the heavy crack in the kadhavadi granite beam. This was also to be replaced.

Joint Commissioner and the Donor inspecting the ground floor slab after being cut

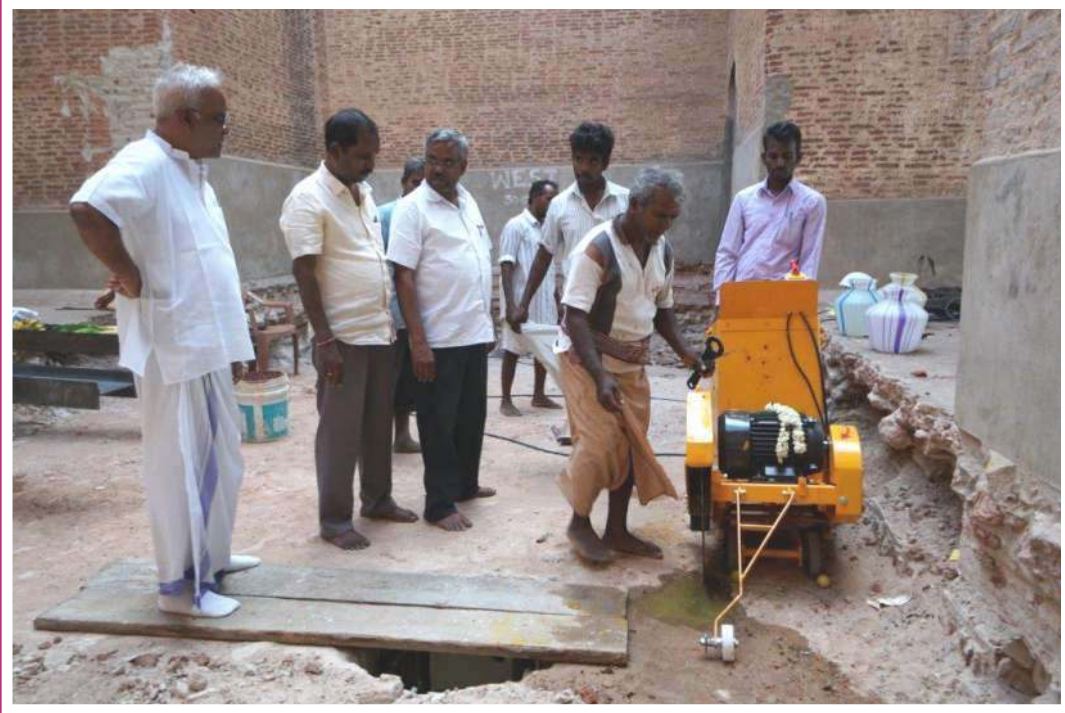
Core cutting process in action

This needs to be executed very carefully without any vibrations / damage to the existing structure. It was decided to use the core cutting technique to remove the existing 200 mm thick two way concrete slab, which was built with 16mm diameter steel reinforcements. For this purpose we have designed and fabricated a suitable machine, capable of cutting 10” thick slab with the 24” circular stainless steel cutter with water cooling arrangements.

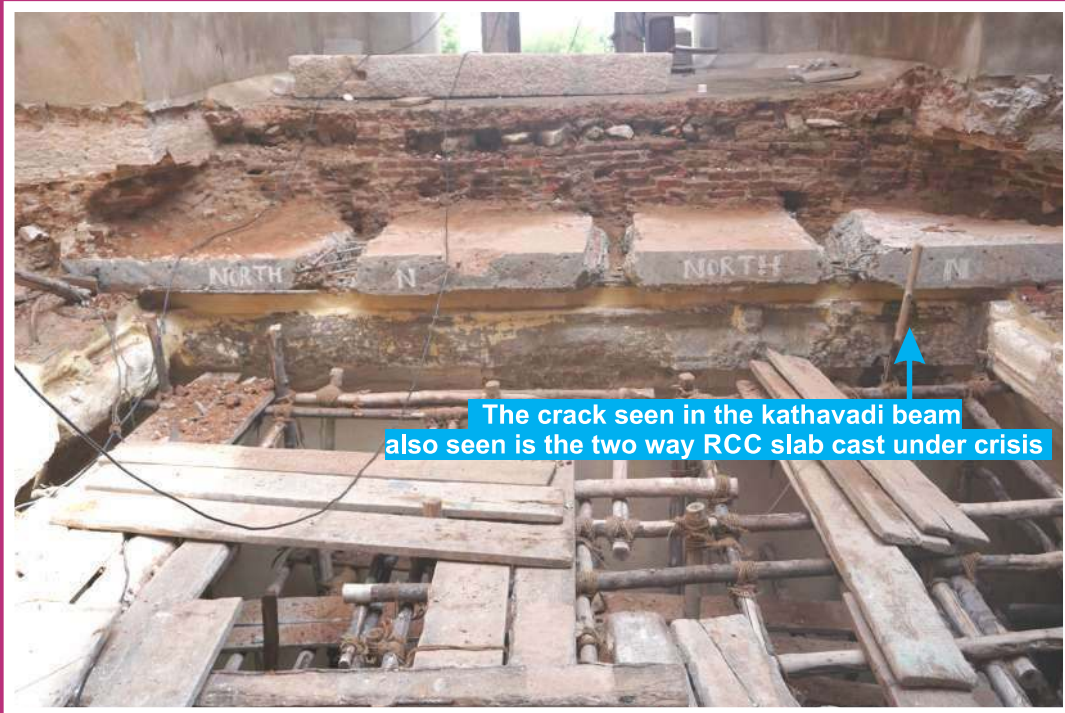
View from the 1st floor - Southern side

Upon further inspection after partially removing this dummy wall, we were shocked to find another crack on the top door frame. The sculptures on the door frames were also damaged.

This lead us to further washing the ceiling near to this dummy wall at the entrance to remove the white washing. Another major crack was noticed on the muha uthiram. This is a pretty heavy granite beam (25 feet length, 5 feet width and 4 feet height, approx. weight 25 MT.)

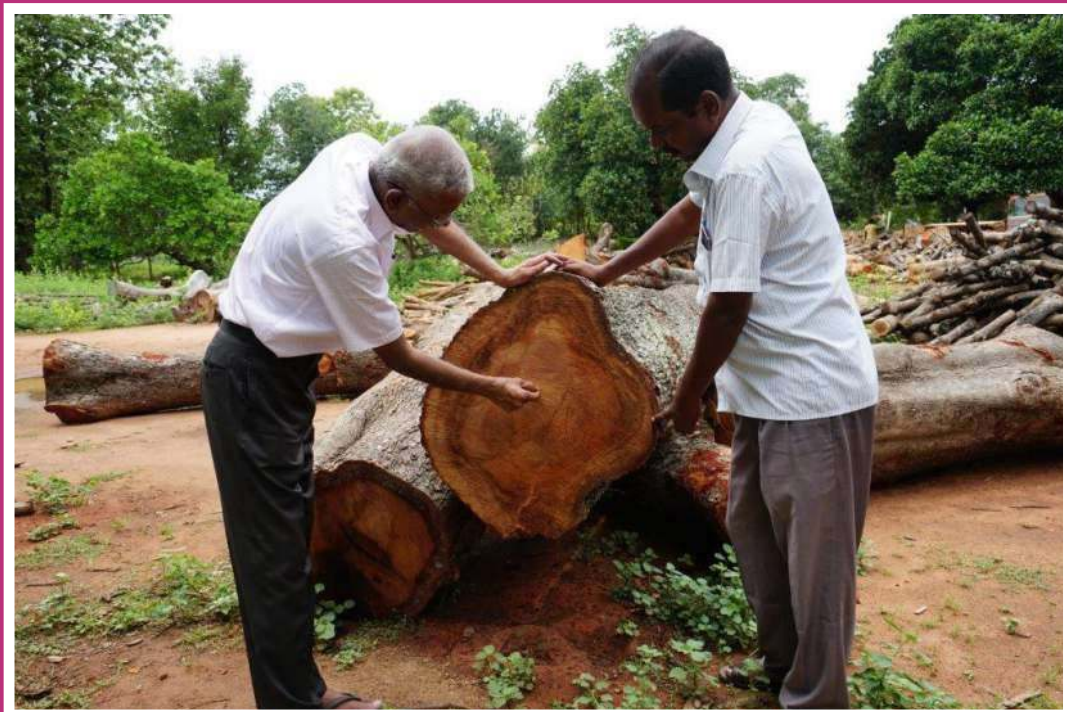
View of the Illupai wood logs, waiting to cut to the required sizes

These sized beams need to be given a protective coating, to protect the attacks from the thermites, insects etc., This protective coating is a tailor-made from the cashew nut oil along with some herbals.

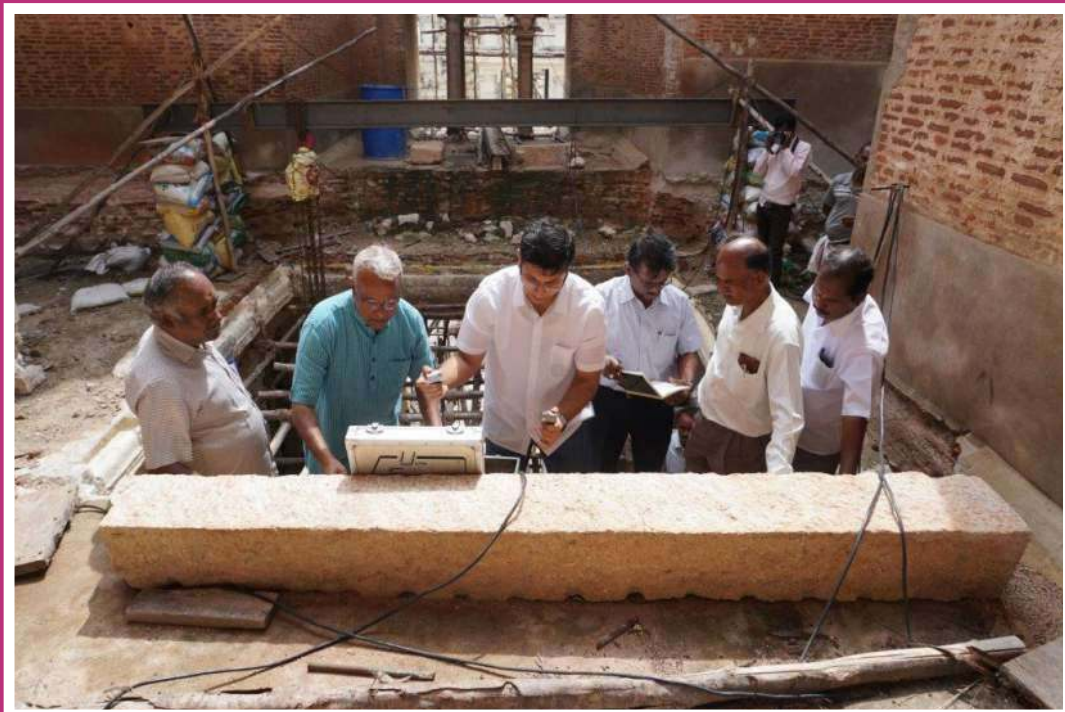
1. The muha uthiram – beam at the entrance ceiling approx. weight 25 MT through and through crack in the middle
2. Door frame approx. weight 15 MT – again cracked on the western side
3. Kadhavadi beam – supporting the concrete structure weight 25 MT cracked on the eastern side

The team testing the granite beams (kathavadi) for cracks

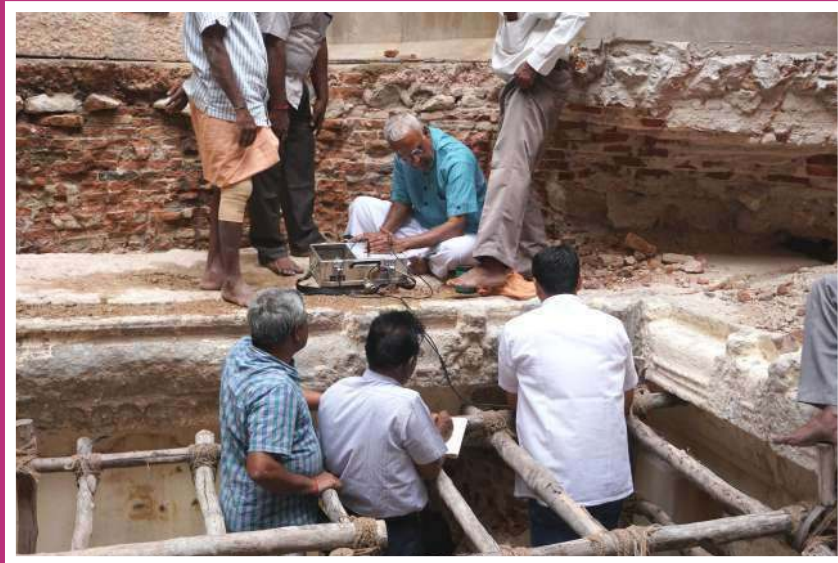
Kathavadi granite beam

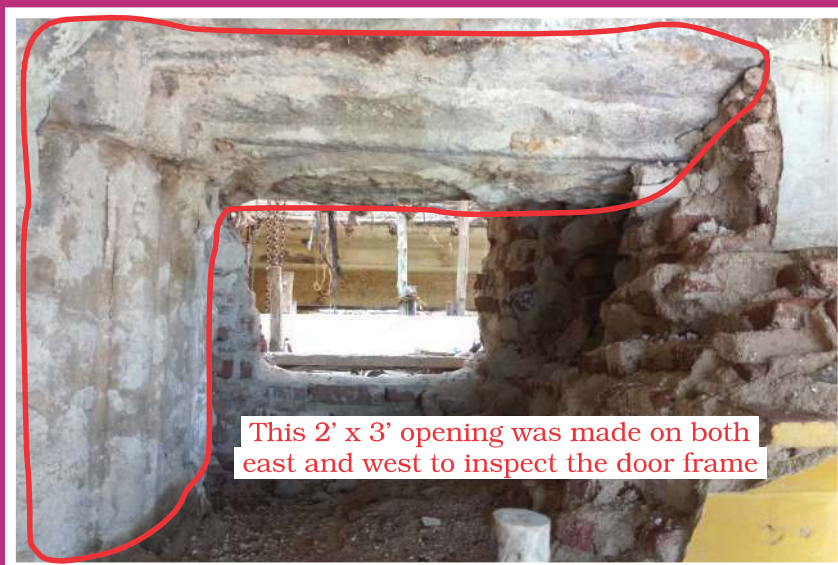
This 2' x 3' opening was made on both east and west to inspect the door frame

Damaged door frame

Possibly this could be the reason for constructing the 6' w & 20' ht dummy wall reducing the opening at the northern entrance

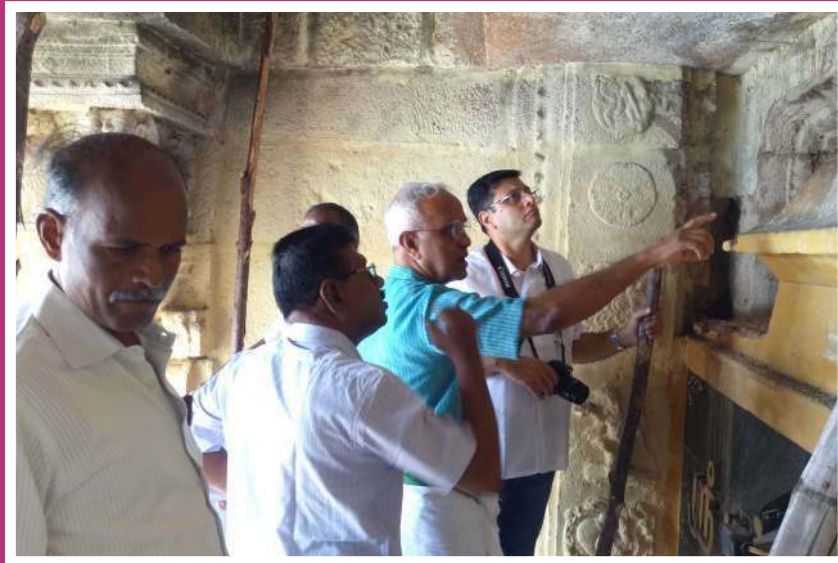
The general view after removing the concrete slab to be closed, with granite beams / slabs as per the Agama sashtra

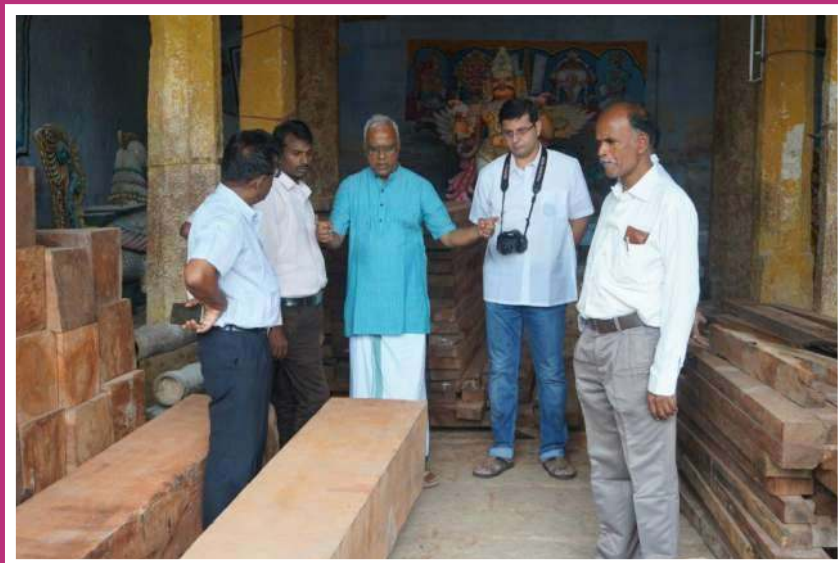
The team inspecting the sized illupai beam

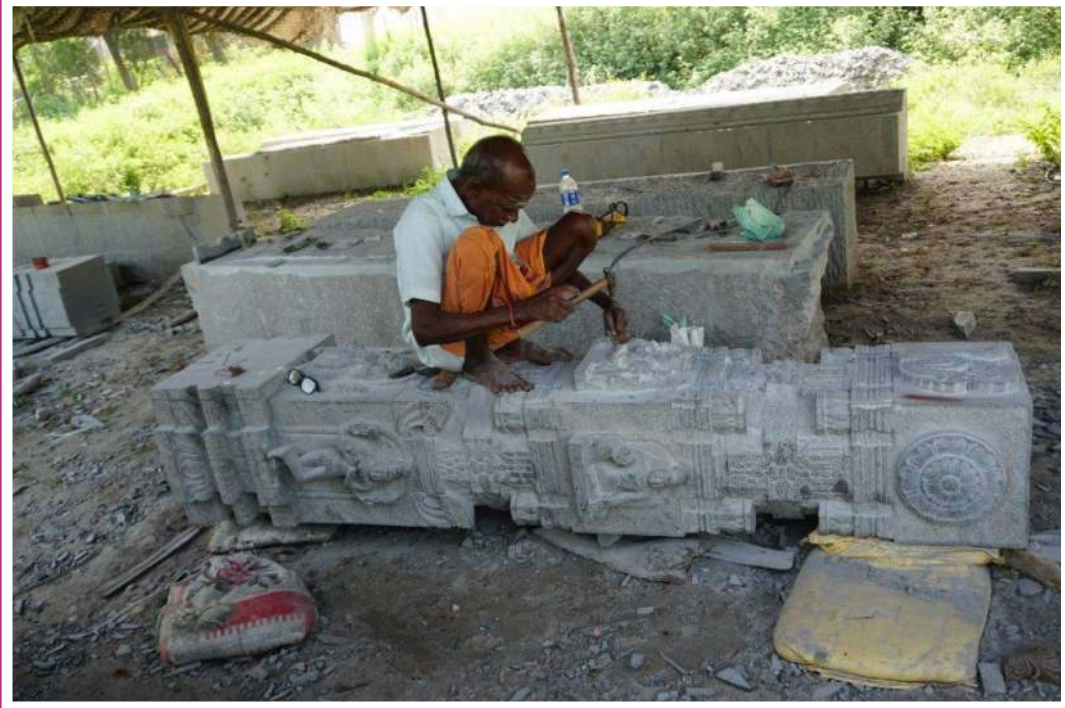
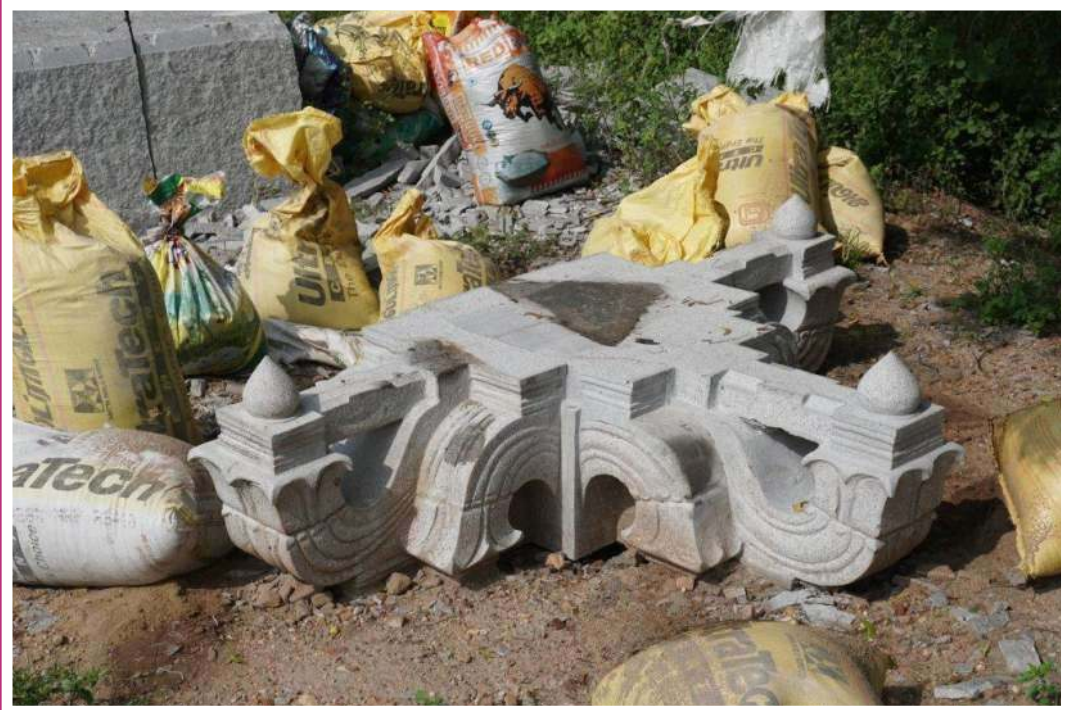
Completed Pillar and the Bhodhi

After inspection, it was decided to replace these three beams. Accordingly, these three beams arrived at the temple site on Feb 2017 and the sculptors are working on it.

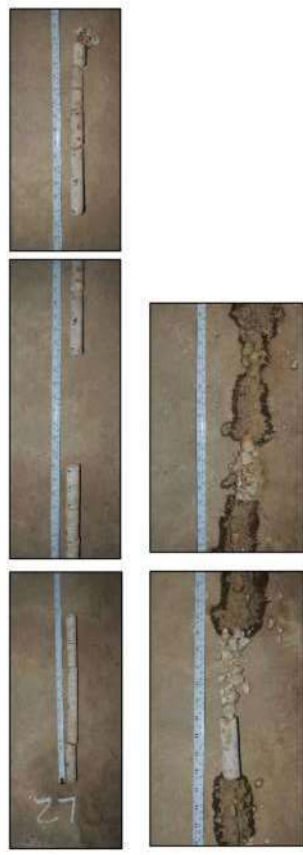
Plan at 5.25 m lvl

Wet core drilling 35 mm Ø executed on 12th September 2015.
The core at L2 is drilled at height of 1.28 m from finished floor level (landing).

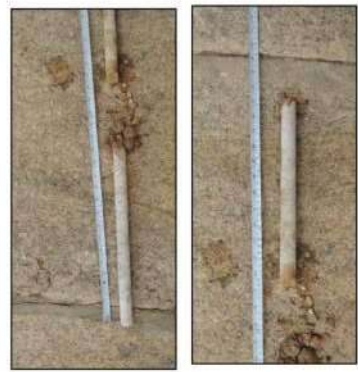
Wet core drilling 35 mm Ø executed on 12th September 2015.
 The core at L4 is drilled at height of 0.5 m from top level of the fortification wall. Total height from the ground level is 5.56 m

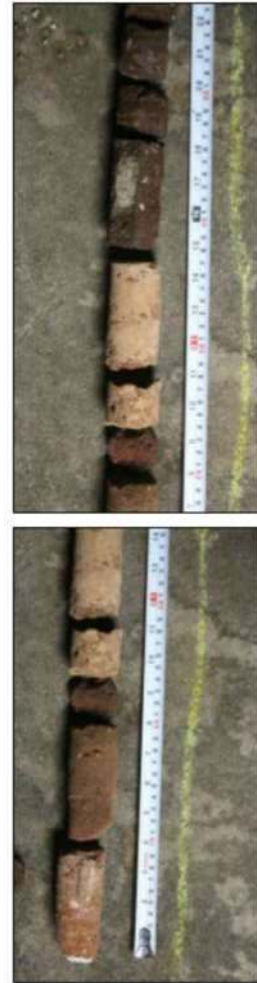
A combination of Dry and Wet core drilling 35 mm Ø executed on 31st October 2015.
 The core at L1 is drilled at height of 1 m from finished floor level. The Dry Coring was done till a depth of 30 cms.

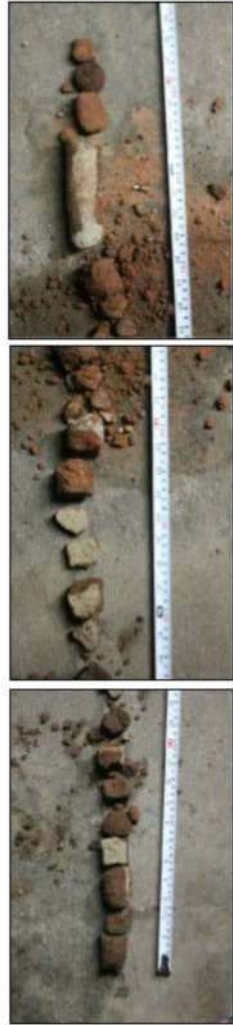
(L3)

A Wet core drilling 35 mm Ø executed on 31st October 2015.
The core at L3 is drilled at height of 0.45 m from finished floor level.

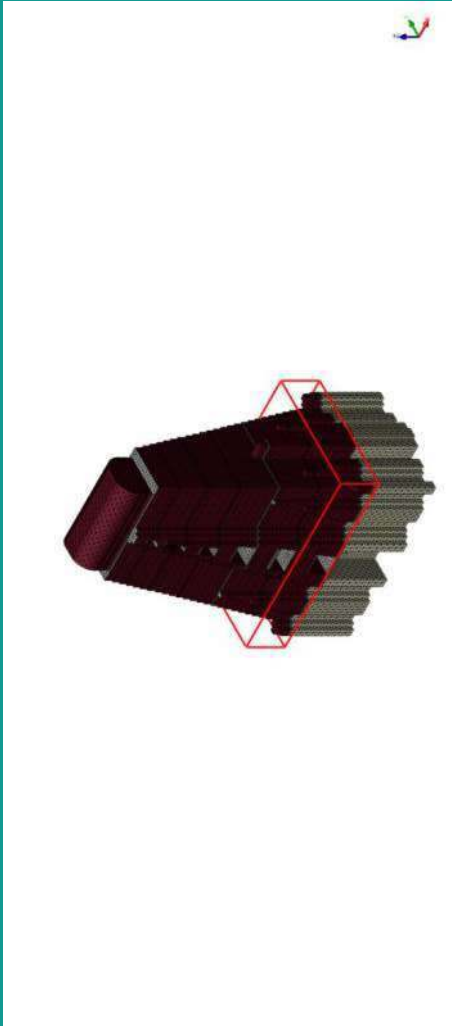
2 & 4	BRICK INFILL COMPRESSIVE FAILURE

<p style="text-align: center;">LEVEL 2</p>
	BRICK INFILL COMPRESSIVE FAILURE	<p style="text-align: center;">LOCATION</p>
	BRICK 1-28 C1 & C2 PROPOSED STATES	<p style="text-align: center;">PRINCIPAL STRAINS S3</p>
